COLES GREEN COURT

CONDITION REPORT FOLLOWING SITE VISIT ON FRIDAY 4 JANUARY 2013

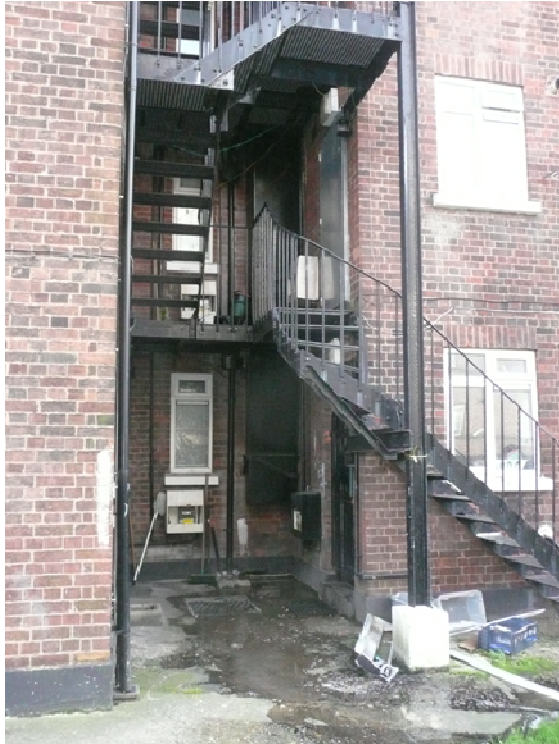
1. External Fire Escapes

The internal layout of the properties created emergency escape issues in the event of a fire. Two steel staircases have been installed to the block. These facilitate the escape from the building via a new door opening in the kitchen. The staircase is not maintained. In addition there are no fire doors in the properties and this would create a severe risk in the event of a fire. Residents may not be able to be protected long enough to reach one of the fire escapes, or for the rescue services to reach them in the event of a fire.

This requires significant internal re-modelling to most of the flats. This can not be estimated at present as it is likely to lead to major structural works throughout the block.

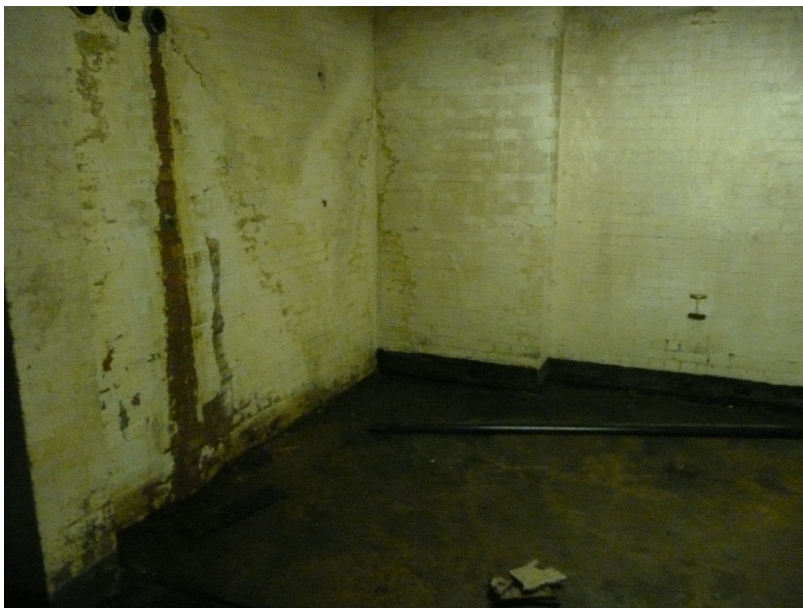
2. Basement

There is severe flooding to the basement of the block. This appears to have been occurring for some time. A sump pump is installed but has ceased to operate.

This long-term flooding is likely to have created severe issues with the under building and foundations. This could lead to issues with the structural integrity of the building.

This requires extensive intrusive investigation from a specialist to determine the damage to the building and the extent of the remedial work required.

In addition this type of work to the underbuilding and foundations of a building are likely to require a full decant of the building due to the likely results of the risk assessment that would be undertaken.

This flooding has been taking place over several years and it is likely that there will be a significant cost associated with survey, underpinning, re-building, drying out, protection, and management and re-location of residents.

It is difficult to place an estimate on this work but it could be between £100K and £500K.

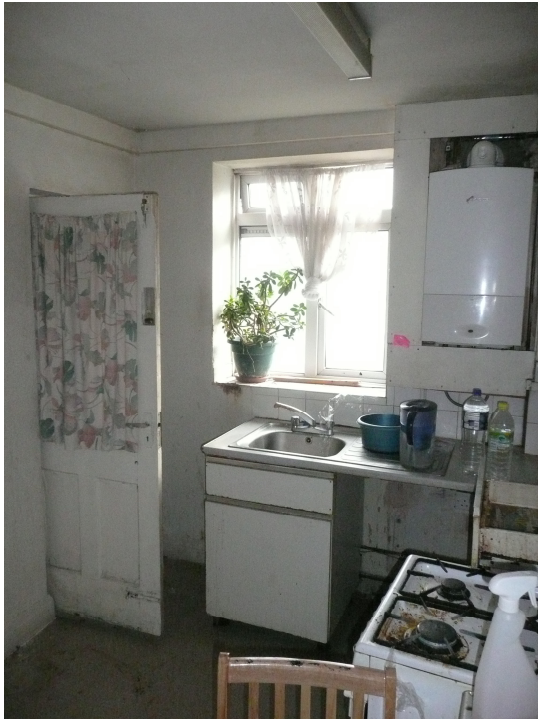
- Kitchens

Most of the flats will require a full internal refurbishment with kitchen, bathroom, front door, electrical and heating upgrade, etc. This is essential to provide good sanitation and comfort for residents.

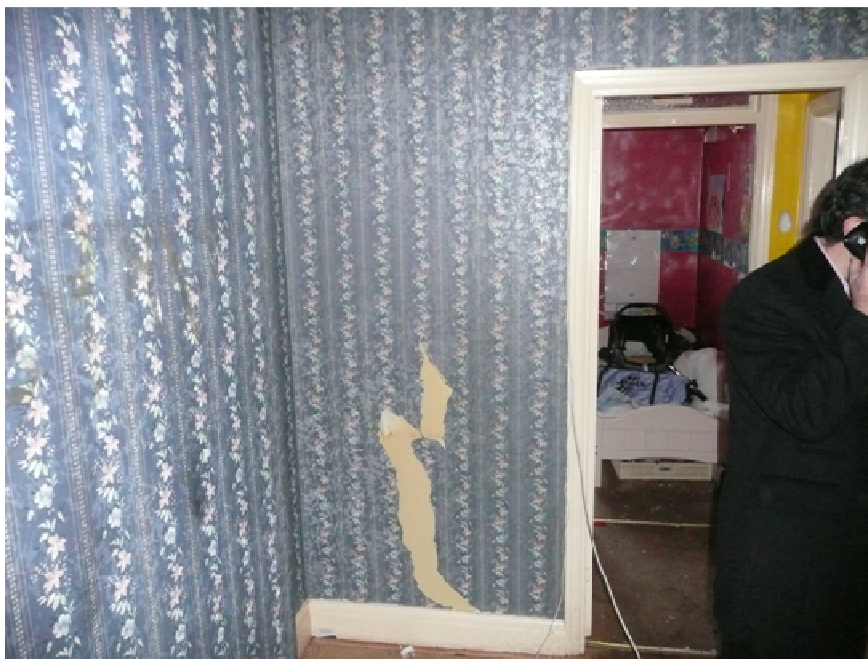
- Bedrooms accessed through Living Room

The current properties are poorly laid out resulting in lack of space for accommodation, installation of white goods, and lack of storage.

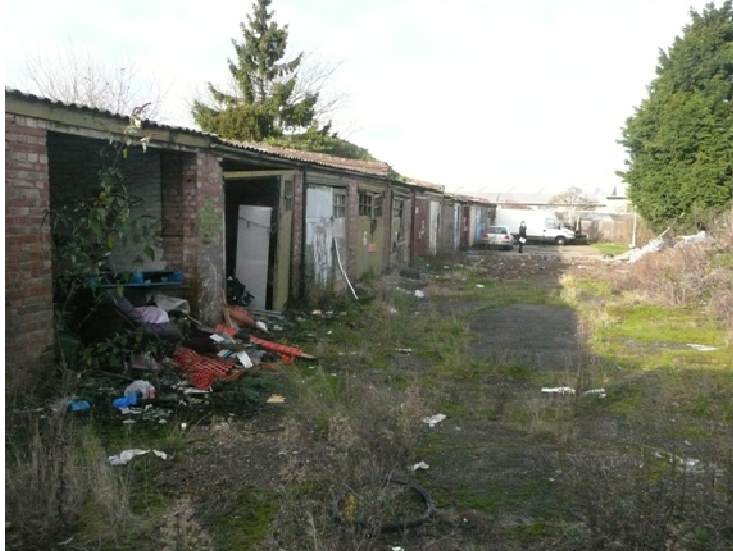
6. Rear Garage Area

The dis-use of the garages has resulted in residents parking on the rear grassed area. This has created fly tipping issues and anti-social behaviour. This creates a feeling of dereliction and overcrowding.

There is a block of approximately 17 garages at the far rear of the site that are past repair. These require demolishing and rebuilding. This would cost circa £150K - £200K.

The area of ground and at the rear of the site requires to be landscaped. Cost is circa £25K.
