# Fire Risk Assessment Review

Property Address:  
Thamary,  
34 Steele Road,  
Park Royal,  
London.  
NW10 7AS

Date of Inspection:  
4 May 2019

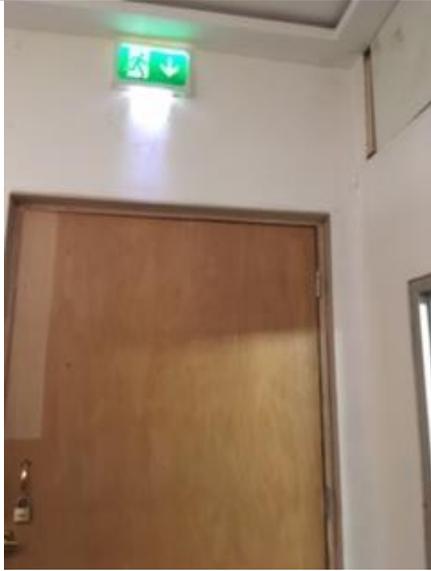
The main entrance/exit door has to open outwards and have a push bar to open.

All doors along escape routes need to be easily opened and open in the direction of escape.

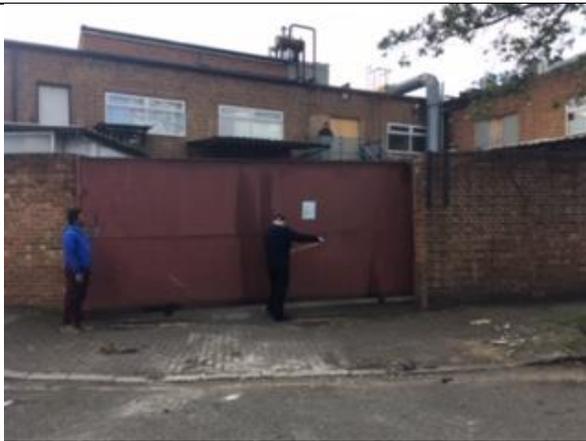
There is a manual sliding metal door at the back of the premises which leads out onto Disraeli road. This needs signage on the inside giving staff or customers clear instructions of how to open it and signage to advise that it is a fire escape.

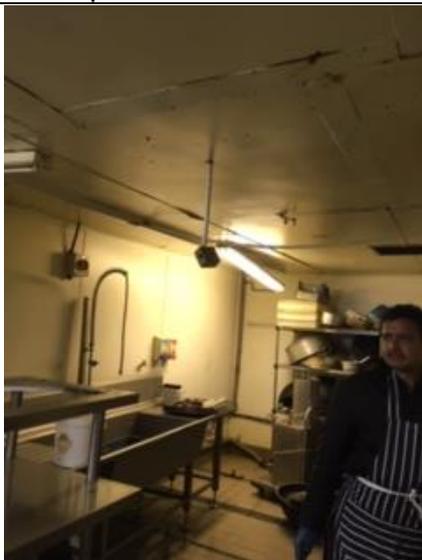
The structure above the downstairs kitchens needs to be checked.

Light fittings hanging off ceiling. Structure of kitchen ceiling needs to be checked. Heat detectors to be fitted.

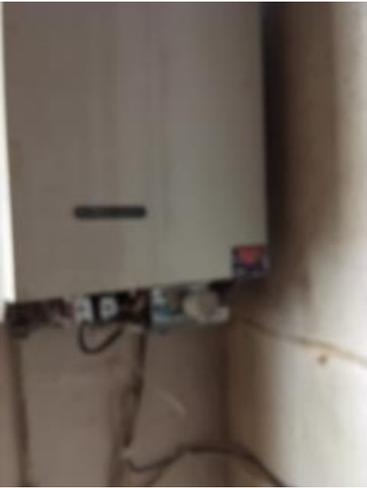
<p>We have not seen any certification for gas and electrical equipment.</p> <p>There is no carbon monoxide detector in the boiler room or the kitchen area. The boiler has the cover missing, this needs to be fixed.</p>

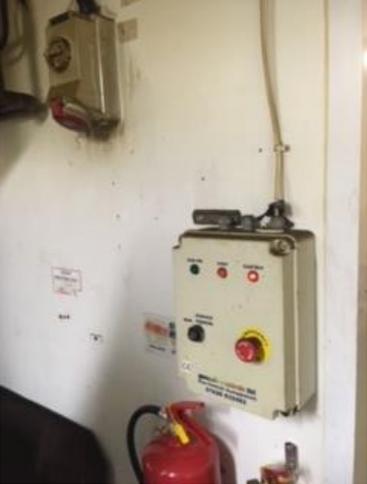
<p>Signage required to alert staff of gas cut off button.</p> <p>It is imperative that a responsible person ensures that all staff know how to isolate the gas supply in case of emergency.</p>

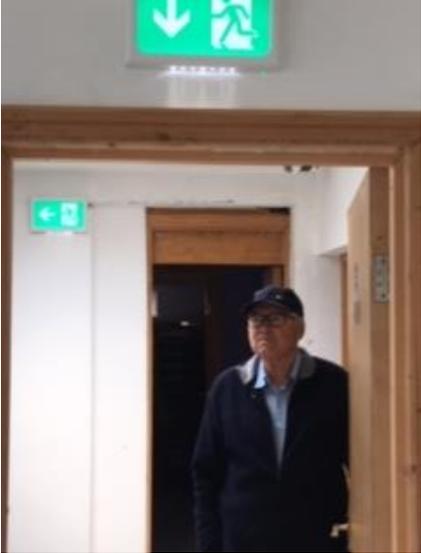
<p>Due to 2 of the fire escape routes in the upstairs banqueting hall being opposite each other it is important that this door has a self closing device fitted.</p>

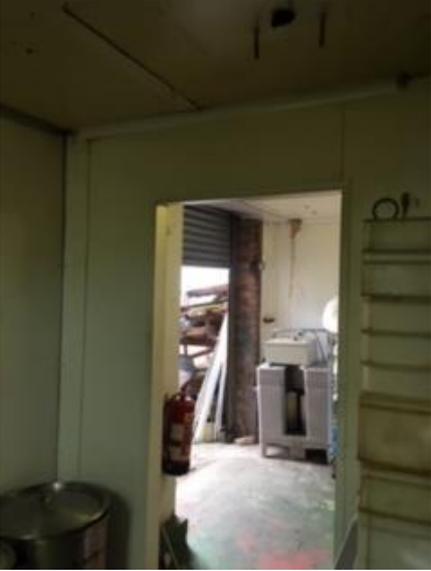
<p>The chain to manually open the shutter must be on display. Signage to be on display.</p>
	<p>There are some battery operated smoke detectors and some electrical smoke detectors. They should all be fitted on an interlinked grade A/C alarm system.</p>

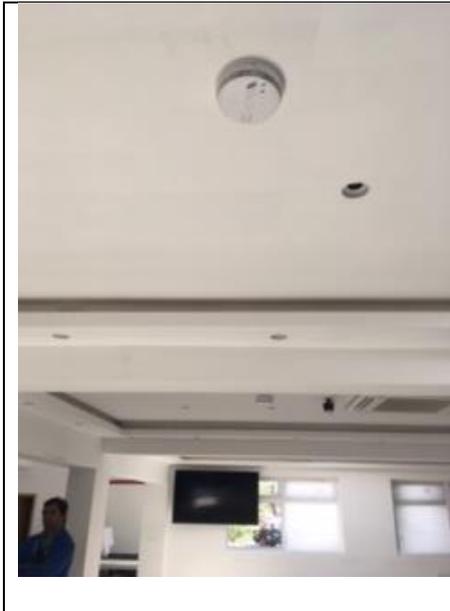
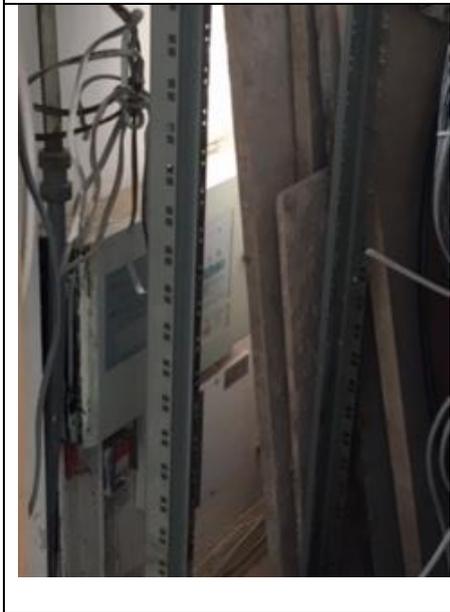
<p>The fire control panel is currently disconnected. As it will be obstructed by the DJ box which is being constructed, it would be a hazard if reinstated.</p> <p>A fire panel should be located in an area common to all building users and where automatic detection is in use, the Control Panel should be in a protected area.</p>
<p>Upstairs kitchen</p>		<p>We were advised that this kitchen will not be used.</p> <p>If use of this kitchen was initiated it would need a fire blanket and fire equipment and a call point.</p>
<p>Housekeeping</p>		<p>We were assured that still in process of clearing clutter and this will all be removed.</p>

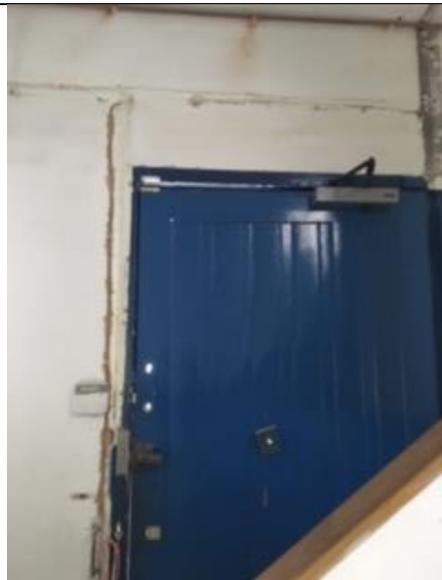
Fire door needs emergency lighting installed above it and should open in the direction of escape.

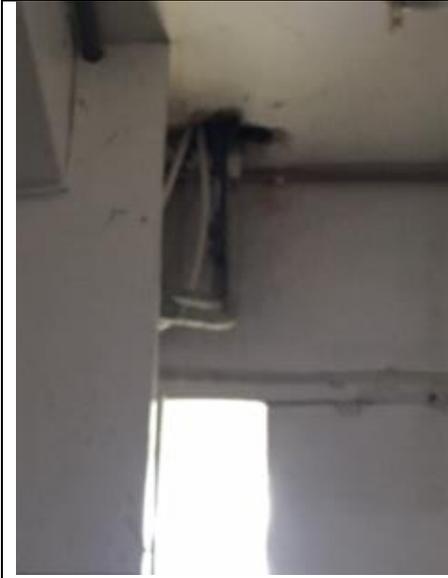
<p>Holes in ceiling by fire exit door – cavities and voids should be filled with fire retardant foam.</p>

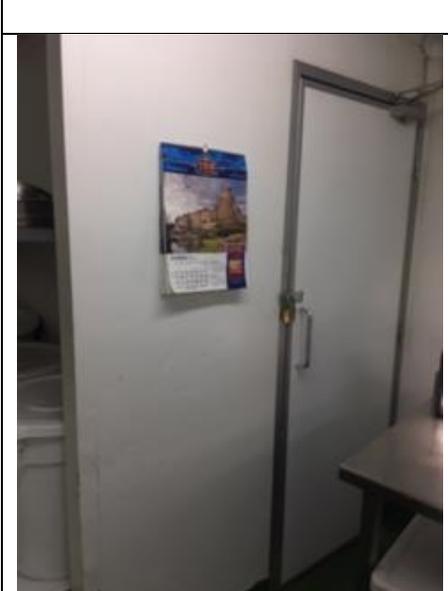
<p>Electrical cupboard needs hazard signage and should not be obstructed.</p>
<p>Evacuation Plan</p>		<p>Nothing in place at present.</p>
