**Report for London Borough of Brent**  
Kilburn Library, Salusbury Road, London NW6 6NN

Accessibility Audit

05 September 2022

Prepared By: Sam Crowe MRICS

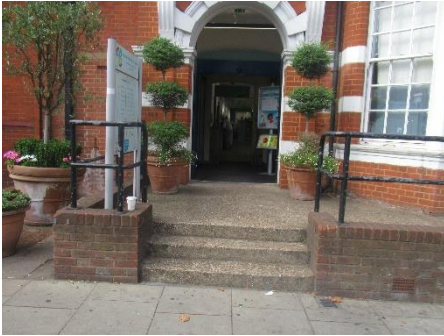
Item	Element	Observations	Recommendations	Cost £	Priority	Photo
1	<b>Externally</b> <b>Parking</b>	There is no vehicular parking provision to the Library.	No action required	n/a	n/a	n/a
2	<b>Approach to building</b> i Main entrance	The main entrance is stepped, measuring 1600mm wide with 3no steps measuring 130mm Risers and 250mm Goings. Nosings are absent from steps. Tactile paving is absent from steps. Guard railings are provided which serve as a hand rail but this does not meet the standard requirements for a handrail.	Fit new non slip nosings where missing.  Lay new tactile paving to base of steps.  Install new nylon coated handrail to steps, both sides.	£375.00  £400.00  £2,000.00	A  C

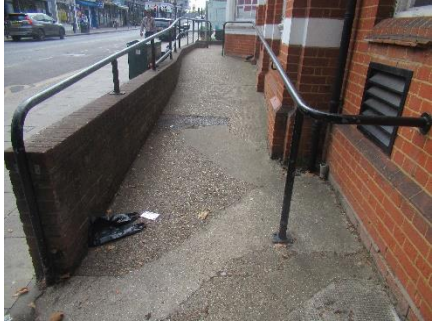
<p>ii</p>	<p>Accessible entrance</p>	<p>An accessible ramp is provided, leading to the main entrance constructed in concrete with a masonry dwarf wall.</p> <p>A painted steel handrail is provided to both sides. Tactile paving is absent.</p> <p>The ramp is 11.34m in length with a rise of 390mm. This is a 1:29 fall and does not meet requirements.</p> <p>There is no level landing at a mid-point.</p> <p>The ramp slope does not contrast with level landings and is not of a slip resistance nature.</p>	<p>Due to site constraints, it is not possible to address the fall or length.</p> <p>Provide and apply non slip finish to slope and level landings.</p> <p>Provide and fit tactile paving.</p>	<p>£675</p> <p>£400.00</p>	<p>A</p> <p>B</p>

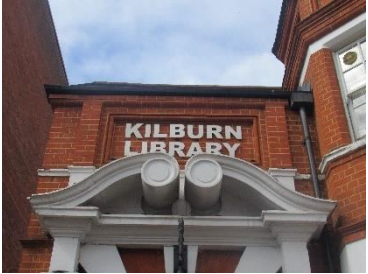
<p>3 i</p>	<p>Signage Generally</p>	<p>Building name signage comprises laser cut stainless steel clear lettering above the no main entrance. The signage contrasts well with the surrounding brickwork.</p>	<p>No action</p>

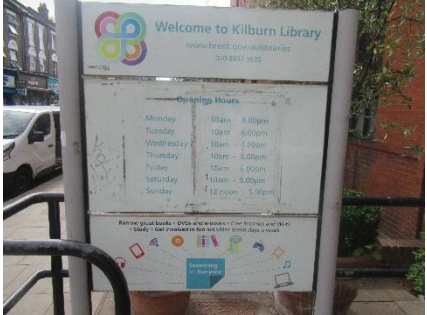
ii	Accessible	<p>An information board is present but is absent Braille lettering.</p> <p>Font choice and colour could be more defined with better colour contrast.</p>	<p>Provide and fit new signage to main entrance. To be in accordance with BS 8300:2018 and the Sign Design Guide and inclusive of Braille.</p>	£750.00	B

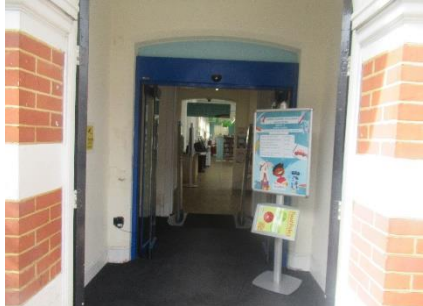
4 i	<p><b>External doors</b></p> <p>Main entrance</p>	<p>The main entrance doors are the original painted timber panelled doors with a fully glazed automatic folding doors. Manifestation is absent.</p> <p>Both doorways have a clear width of 1400mm</p>	<p>Provide and apply frosted film manifestation to folding doors at 900 and 1400mm AFFL.</p>	£150.00	B

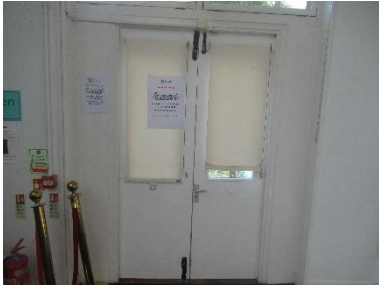
iii	Garden access door	<p>Access to the garden is via painted timber half glazed double doors with a clear width of 1230mm.</p> <p>There is a stained timber threshold which is in excess of 13mm.</p>	Replace with new painted timber door with low profile threshold	£1,500.00	C

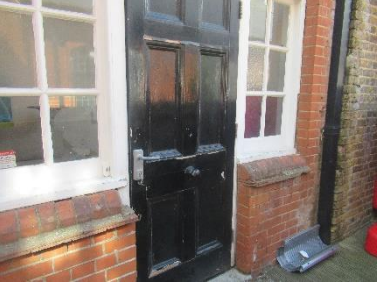
iv	Fire exit doors, North passage	Doors comprise painted timber half glazed panelled single door with a clear width of 770mm and suitable panic exit hardware	No action	n/a	n/a

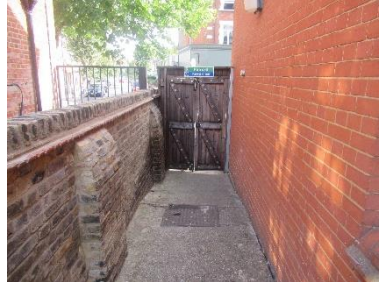
v	Fire exit gates, North passage	<p>The fire exit is a stained timber double gate with a clear width of 1200mm.</p> <p>The method of operation to escape is not within reach of a non ambulant person</p>	Review exit strategy and ensure that a responsible person unlocks the gate in the event of an emergency	n/a	E

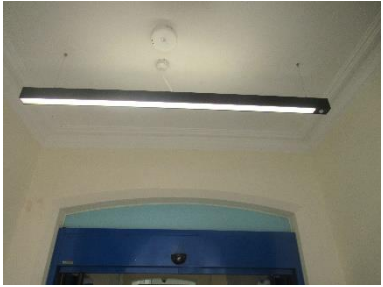
Internally						
5	<b>Transition lighting</b>	<p>Upon entering there is one suspended fluorescent light fitting in the foyer leading into the main library space which has been newly installed as part of energy saving programme of works.</p> <p>The light includes a daylight sensor to ensure levels are adequate at all times.</p>	No action	n/a	n/a

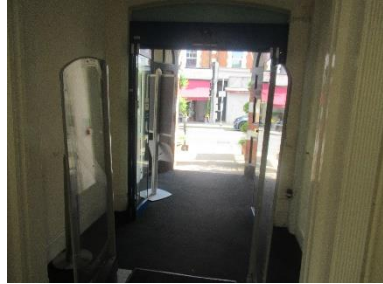
6	<b>Main entrance foyer</b>	<p>The foyer comprises a small entrance lobby comprising painted plaster masonry walls and a floor finished with a multi directional barrier mat, suitable for non ambulant visitors.</p>	No action	n/a	n/a

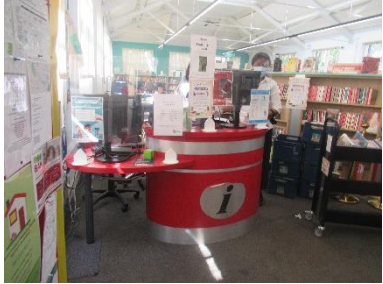
<p><b>7</b></p>	<p><b>Reception desk</b></p>	<p>A small reception desk is provided to the centre of the library. There is a small dropped counter section albeit the desk is filled with PC, screens and equipment blocking any benefit that a non ambulant person may derive.</p>	<p>Desk to be cleared and rationalised if possible, consider replacing the desk with a more suitably sized desk if equipment must stay. In the meantime, put in place a management plan that staff come around desk to discuss queries with non ambulant visitors directly.</p>	<p>£0.00</p>	<p>E</p>

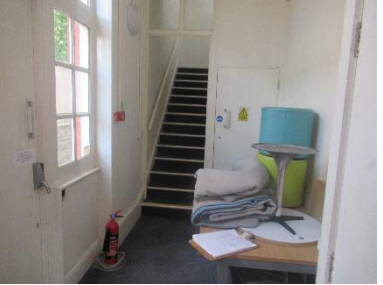
<p><b>8</b> i</p>	<p><b>Lobbies</b> Staff area lobby</p>	<p>Painted plaster walls and ceiling with painted timber skirting with fluorescent bulkhead lights and multi directional diamond pattern carpet.</p>	<p>Consider decorating joinery in alternative contrasting colour.</p>	<p>incl</p>	<p>C</p>

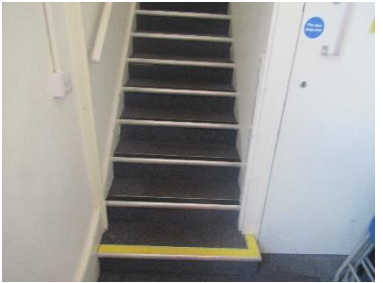
<p><b>9</b> i</p>	<p><b>Staircases</b> Staff area staircase (original)</p>	<p>Timber staircase with painted timber handrail 50mm diameter and a clear width of 790mm. Finished in a dark carpet with yellow nosings to bottom and top steps and dark intermediate nosings which do not contrast with carpet finish.</p>	<p>Replace carpet and/ or nosings so that colours contrast sufficiently.  Building constraints do not allow for a second handrail.</p>	<p>£810.00</p>	<p>D</p>

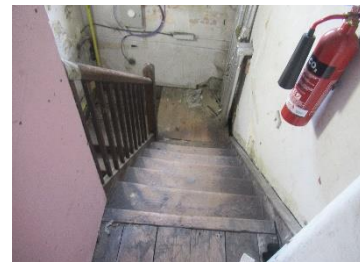
Handrail provided to one side only.  Nosings do not contrast sufficiently with carpet.				
ii	Basement staircase	Original open tread timber staircase with wrought timber handrail for plant access only. Nosings are absent.	Paint on contrasting nosings to comply with BS 8300.	£400.00	A

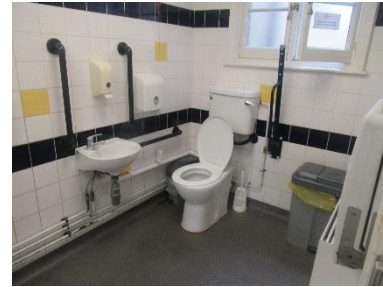
<b>10</b> i	<b>Lifts</b> Main lift	There are no lifts on the property. All public facing areas are at ground level.	n/a	n/a	n/a	n/a
<b>11</b>	<b>Accessible WCs</b>					
i	Ground floor - Public use	WC measures 3 x 1.7m, finished with floor to ceiling ceramic tiles and vinyl floor.  Doc M pack WC is provided with dark blue handrails.  Mirror is absent above the basin but a larger mirror is present on the rear wall. There is no colostomy bag shelf or padded back rest to WC seat.	Replace wall finishes with a contrasting colour, replace emergency alarm, fit new padded back rest WC seat and fit new TMV to regulate hot water to 43°C. Provide and fit new colostomy bag shelf.	£7,675.00	C

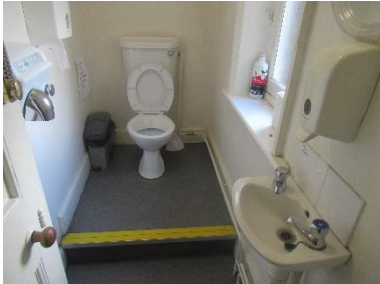
<p>The emergency alarm is broken and the reset button is in the wrong location. Hot water is not regulated to 43°C.</p> <p>Generally in poor condition.</p>				
12 i	<p><b>General WCs</b> First floor - Staff use</p>	<p>Single WC finished with painted plaster and vinyl floor including a step with contrasting nosing. Sanitaryware comprises a close coupled WC and wall hung wash hand basin.</p> <p>Colour contrast between decorations is insufficient.</p>	<p>Renew all and joinery finishes with a contrasting colour.</p>	£300.00	C

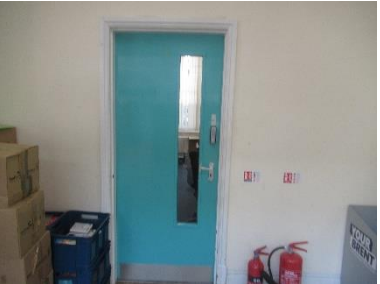
13 i	<p><b>Internal doors</b> Ground floor</p>	<p>Doors are painted timber flush doors with vision panels to offices/ circulation and solid to WCs/ stores. Average clear width approx. 840mm with single polished chrome lever handle at 940mm above finished floor level. Doors are painted in a contrasting colour but door leading edges do not contrast.</p>	<p>Decorate leading edges in a contrasting colour. Consider decorating architrave in a contrasting colour.</p>	£500	C

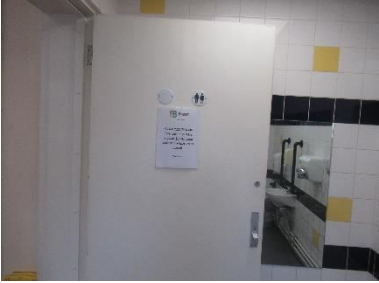
ii	Accessible WC	The accessible WC door is a painted timber flush door with a clear width of 865mm with a compliant accessible toilet lock. A grab is proved to the back face in a contrasting colour.	No action	n/a	n/a

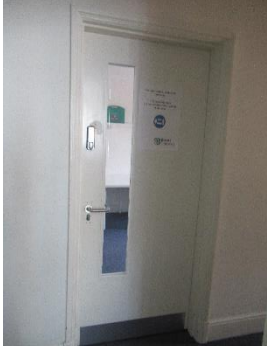
iii	First floor	Doors are painted timber flush doors with vision panels to offices/ circulation and solid to WCs/ stores. Average clear width approx. 840mm with single polished chrome lever handle at 940mm above finished floor level. Doors and leading edges do not contrast with surrounding decorations.	Decorate leading edges in a contrasting colour. Consider decorating architrave in a contrasting colour.	£500.00	C

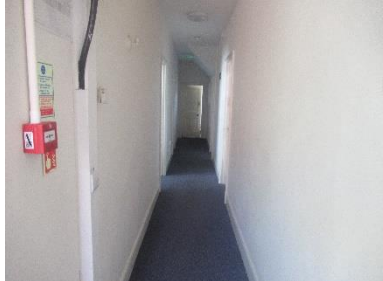
ii	First floor	There is a single corridor with a clear width of 1030mm. Finished with broadloom carpet, painted plaster walls and ceilings. Decorations do not contrast sufficiently.	Ensure decorations at next refurbishment contrast between surfaces.	n/a	n/a

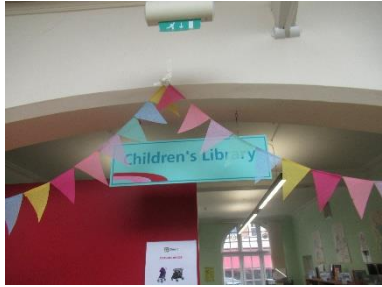
ii	Induction loop systems	The library operates a portable induction loop for those with hearing impairments.	Ensure a management plan is in place for use of portable induction loop system.	n/a	E	
<b>22</b>	<b>Signage</b>					
i	Wayfinding signage	Wayfinding signs are present throughout, being suspended at high level. Some of the signs have very small font and colours do not contrast sufficiently.  There is little or no accessible signage, wayfinding signs do not have Braille.	Provide wayfinding signage at the main entrance. All new signage including that to doors should have Braille to accompany text.	£1,500.00	C

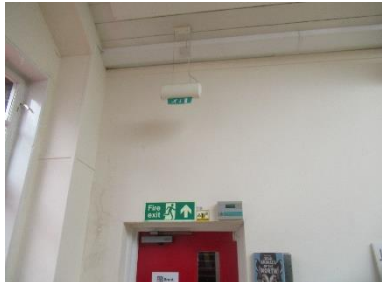
ii	Fire action and directional signage	Combination of photoluminescent and illuminated. Illuminated signs are small and suspended at high level, and not easily read. Some signs present conflicting information.	Replace illuminate exit signage with larger signs and drop the height to approx. 2.6m above finished floor level	£225.00	A

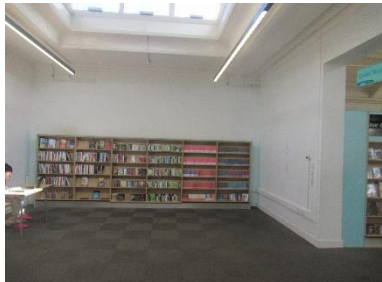
23	<b>Use of Colour</b>	Generally the use of contrasting colours is not good throughout the building with joinery and walls having an LTV of less than 30 points.	Ensure any redecoration programme follows a similar principle of contrasting colours to delineate routes and obstacles	£0.00	C

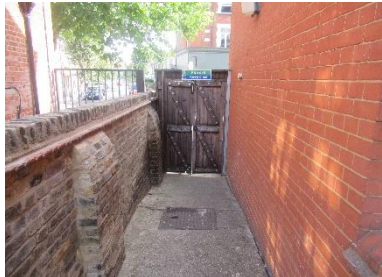
24	<b>Means of Escape in Fire</b> Generally	There are two routes of exit being the main entrance and North passage. Both exits are accessible albeit the final exit to the North passage would be harder to operate.	Review management plan and ensure that a suitable plan is in place for staff and general public through the use of a Personal Emergency Egress Plan (PEEP)	£0.00	E
