Gladstone Park Community Centre Building Inspection Report

Gladstone Park Community Centre
162 Anson Road
London
NW2 6BH

Report Date
23 August 2024

Job Reference: 201777

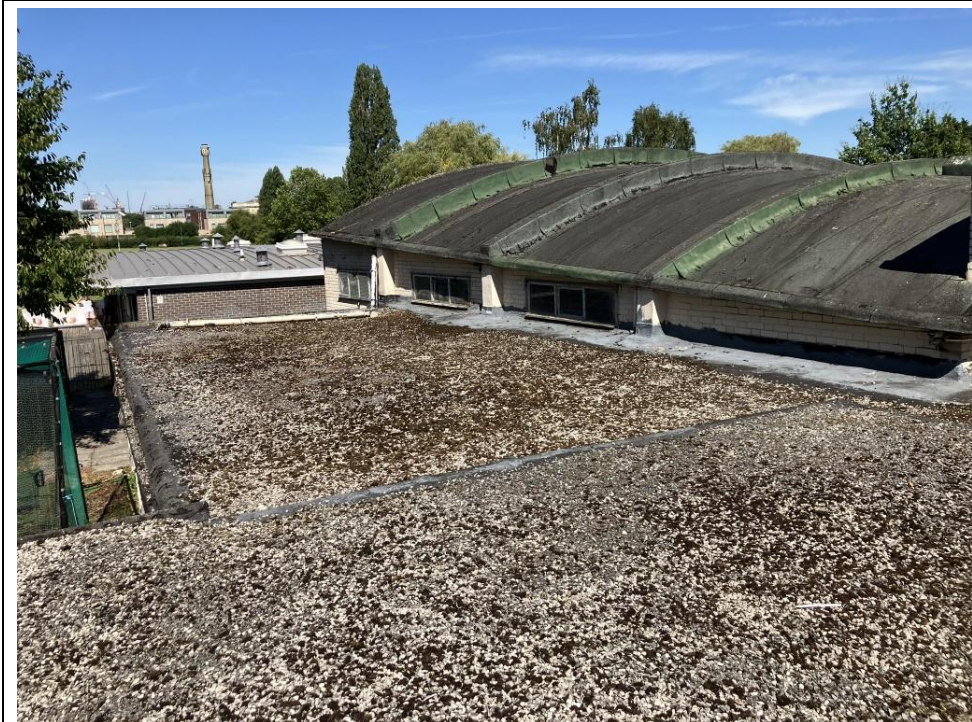
3. East section, mineral felt flat roof.

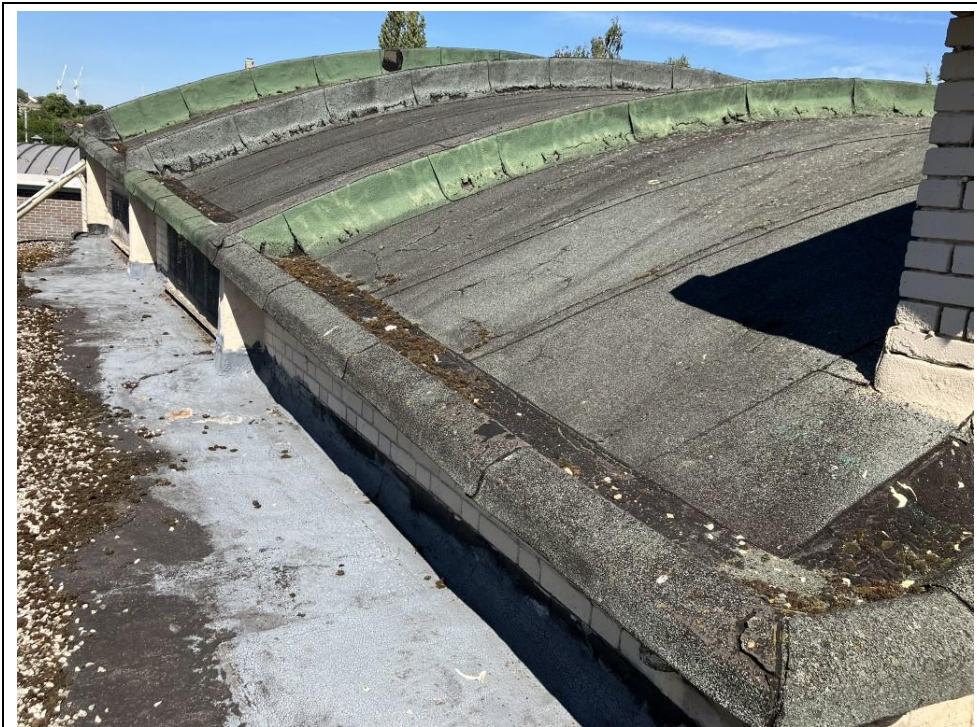
4. Central section, mineral felt barrel roof.

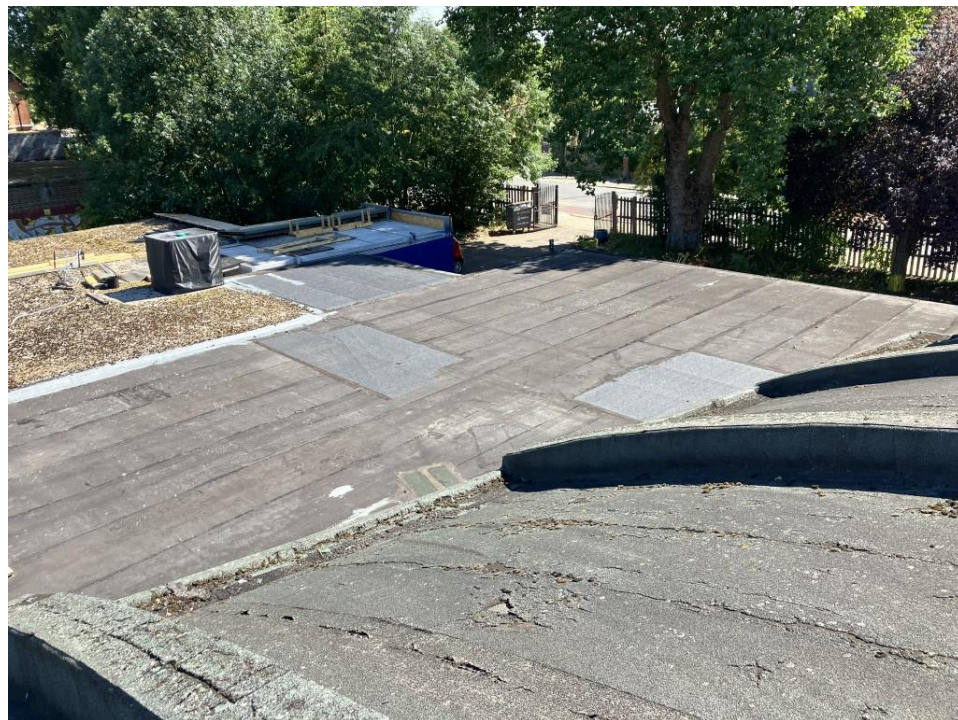
5. West section, mineral felt flat roof.

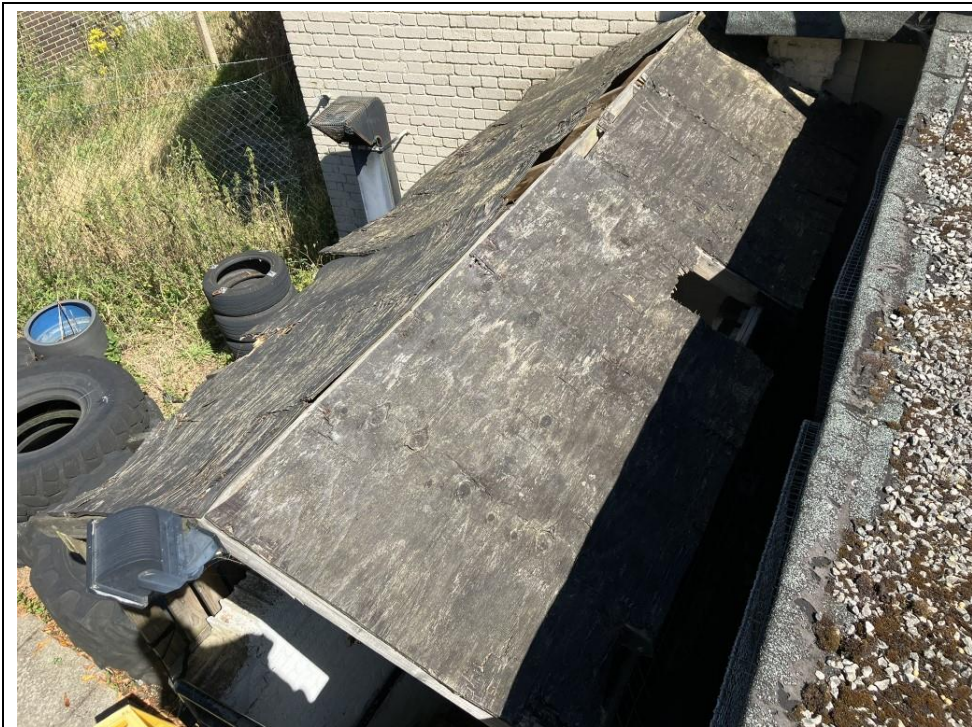
①	<p>The roof over the west basement access stair is in poor condition with no weathering over the ply the ply is degraded, open and section missing and rotten. There is drainage to the bottom of this, it's unclear the reason the shelter may have been erected, whether to minimise water if the drainage was not sufficient or just to simply provide cover for when using the stair.</p>	<p>Consideration should be given to one of the following actions:</p> <ol style="list-style-type: none"> 1) Treat and repair as necessary the timber support structure, remove and replace the failed timber roof, the roof to be finished with mineral felt. 2) Remove and dispose of the failed timber roof and support structure. Allow to test drainage is adequate. <p>For cost minimisation purposes, we recommend proceeding with option 2.</p>
③	<p>Rainwater goods are in varying condition. The downpipe to the northwest corner of the barrel roof has detached and has been twisted and rested on the flat roof in a poor ad hoc way. A downpipe is missing to the southeast corner of the east flat roof. Paint is flaking from the cast iron rainwater goods.</p>	<p>Overhaul rainwater goods, refixing and repairing, redecorating and replacing where missing.</p>

6. To basement access stair, timber pitched roof to rear.

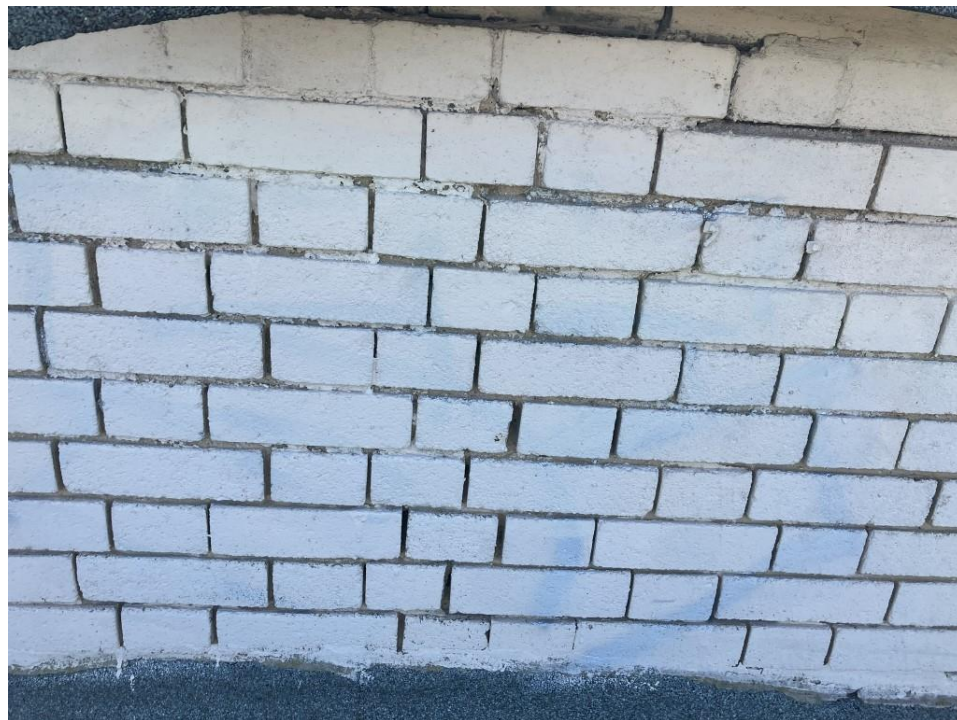
9. Central section (roof level), indicative failed pointing.

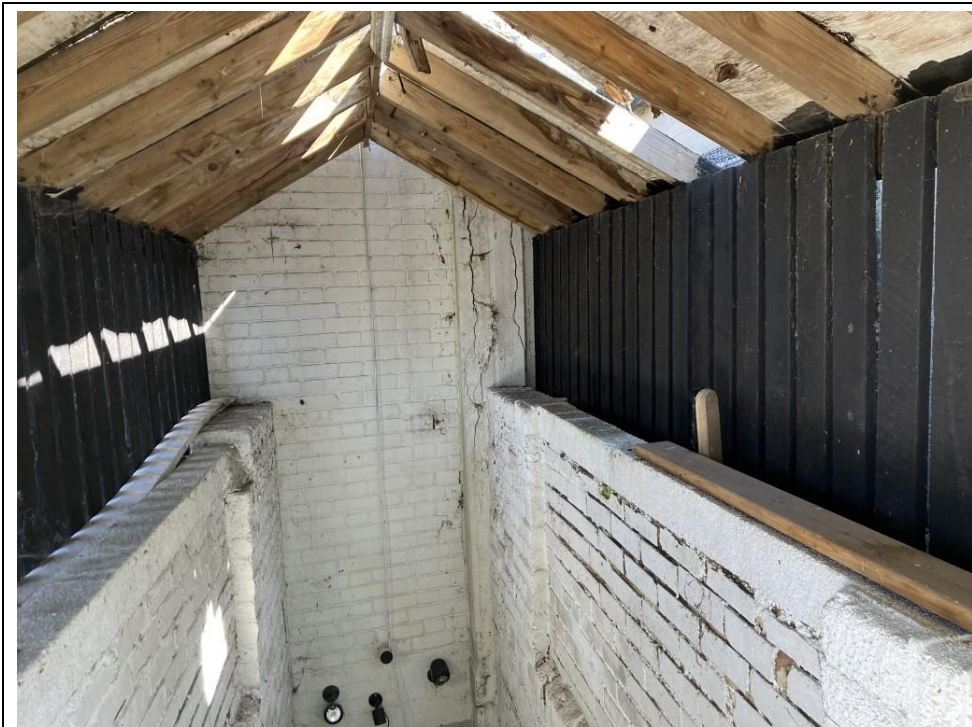
Observation	Recommendation
2	Horizontal and parallel vertical cracking was observed to a concrete post to the rear of the barrelled roof central section west elevation (by the basement door), it appeared to be a moderate crack (circa 5mm to 15mm thick). Fine cracking was evident vertically down a few concrete columns to the barrel-vaulted roof block.	Repair cracking to concrete columns and monitor for reoccurrence. Redecorate as part of redecorations to elevations.
2	Diagonal cracking emanates through the external wall (from opposing corners of the window) and opposite internal wall that surround what was the shower room (to the southeast corner of the central barrel roofed block), a moderate sized crack circa 5-10mm.	Repair cracking through brickwork allow to install stainless steel ties.

10. Central section, rear basement door, crack to concrete support.

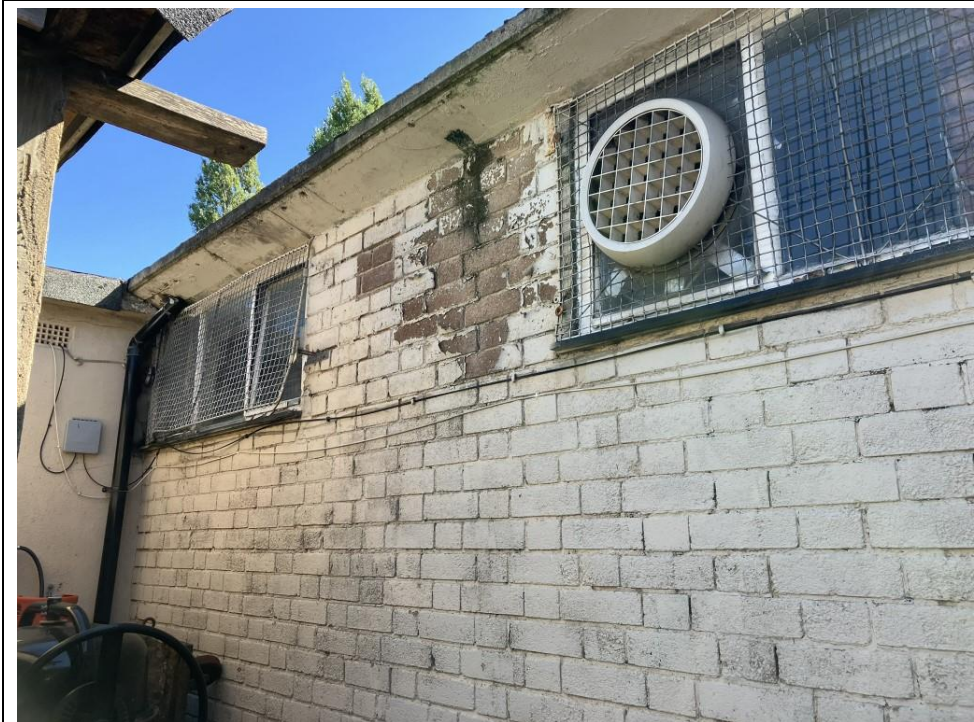
13. Rear elevation west section, missing rainwater outlet.

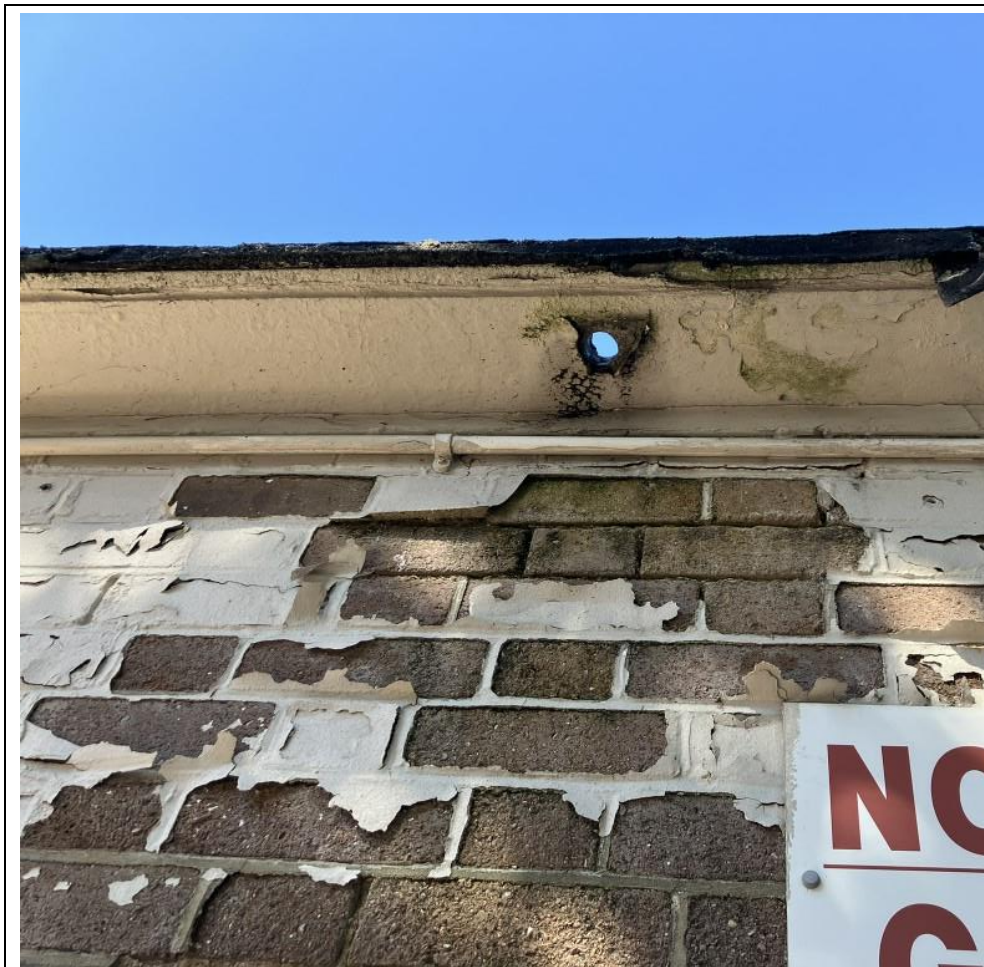
14. Front elevation east section, missing rainwater outlet.

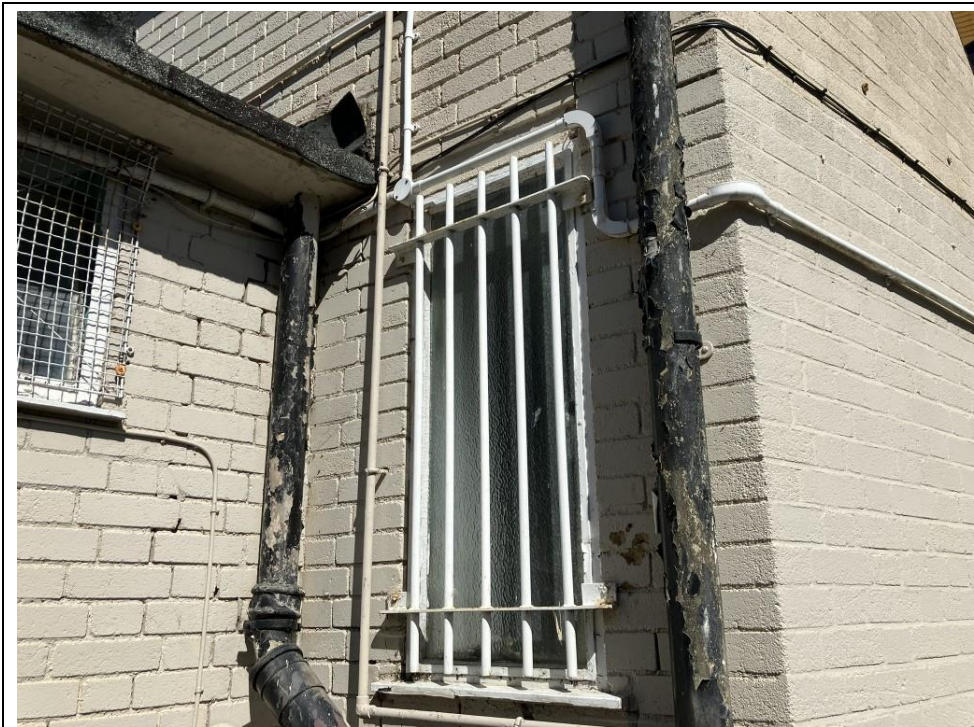
15. Front elevation central section, cast iron downpipes and window bars.

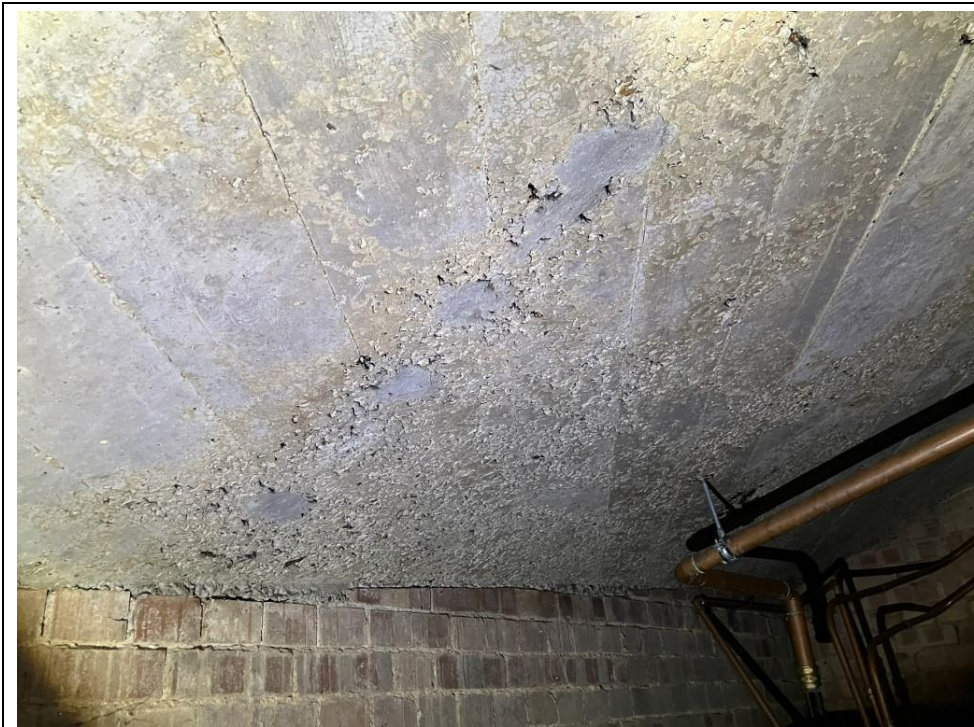
Observation	Recommendation
2	<p>A loft to the barrel-vaulted roof resides over the entrance hallway accommodating the water tanks. Localised spalling concrete soffit was evident.</p> <p>It was accessible via an access hatch which did not have an in-built loft ladder.</p>	Monitor spalling concrete for any signs of further deterioration. Repairs are not considered necessary if the building is to be redeveloped in the medium to long term.
1	<p>Ceilings are in poor decorative condition throughout. At ground floor there is mould growth widespread throughout (a hazard to respiratory health) including to walls. Water damage was observed to the west and central sections of the property, indicating penetrating rainwater ingress, including localised spalling to the concrete soffit.</p> <p>The southwest corner of the west flat roof soffit appears to slump in the middle, this appears to have been poured insitu concrete so consider this most likely a as built deformation rather than deflection. Observation only.</p>	<p>Specialist treatment to remove all mould growth throughout, must be undertaken in tandem with increased ventilation as noted under the building services section.</p> <p>Repair spalling concrete. Clean, prepare and redecorate throughout.</p>

23. Loft space, spalling concrete.

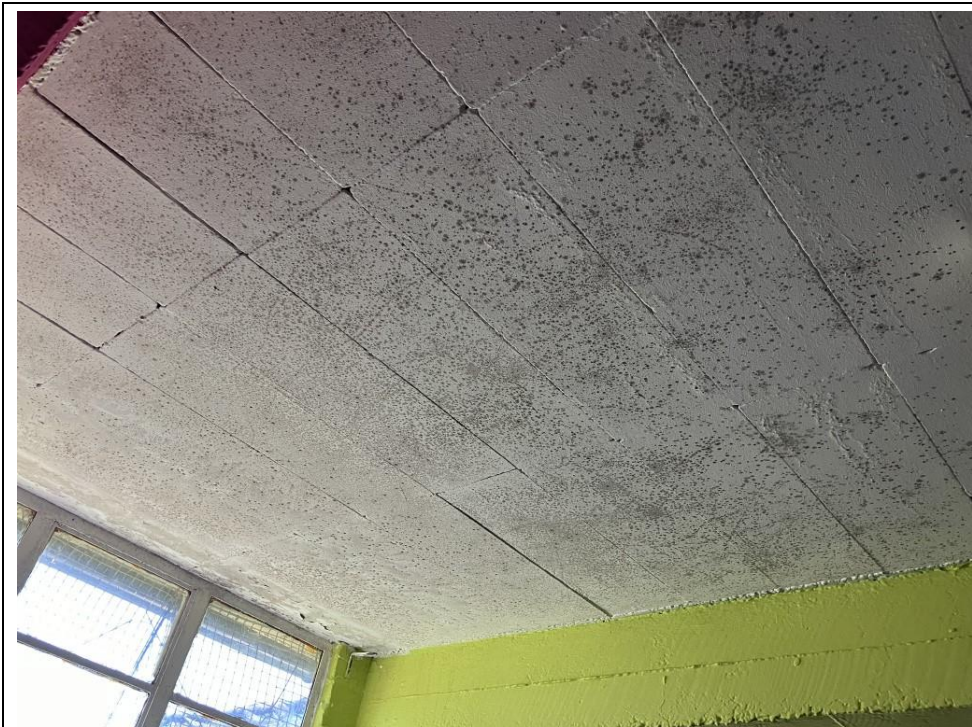
25. Ground floor east section, typical mould growth.

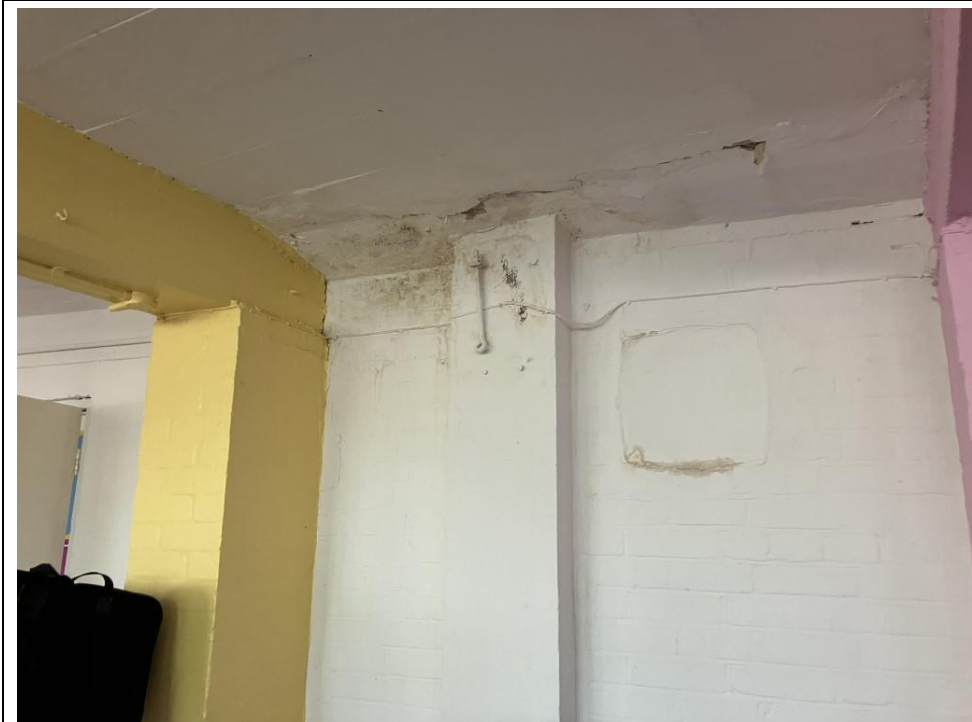
26. Ground floor east section, typical water ingress stain.

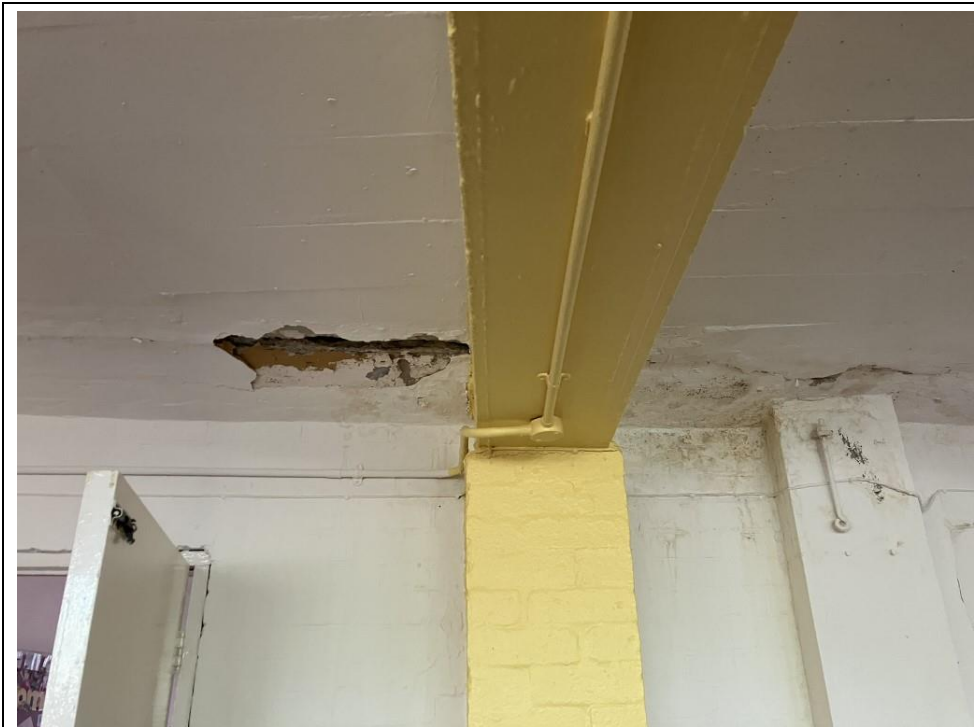
27. Ground floor east section, indicative ceiling failure.

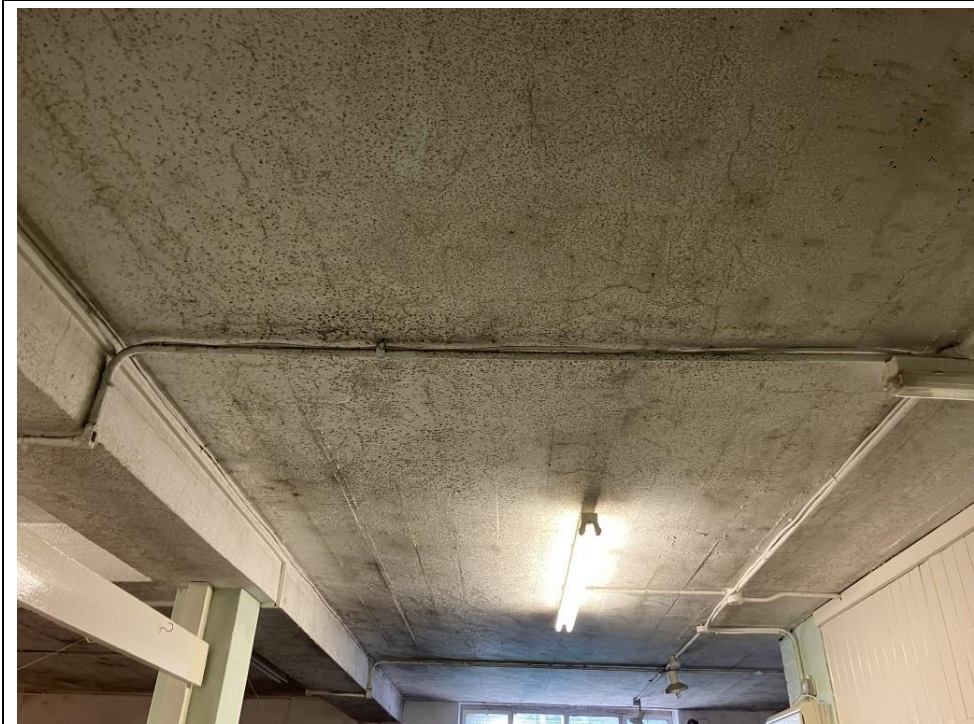
28. Ground floor west section, typical mould growth.

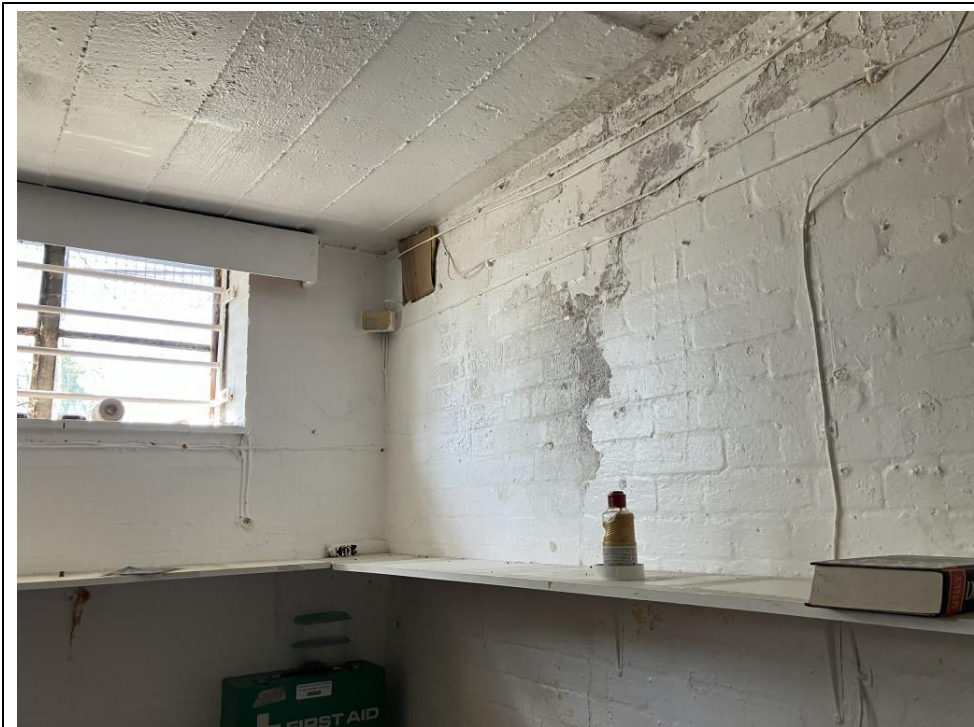
29. Ground floor east section, stained painted masonry wall.

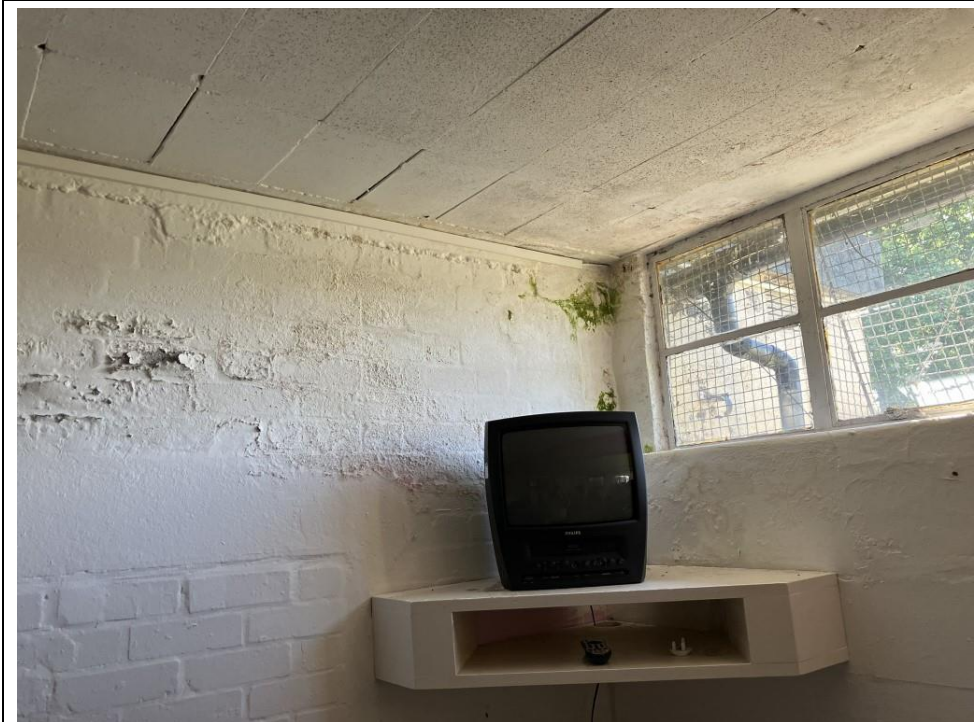
30. Ground floor east section, stained painted masonry wall.

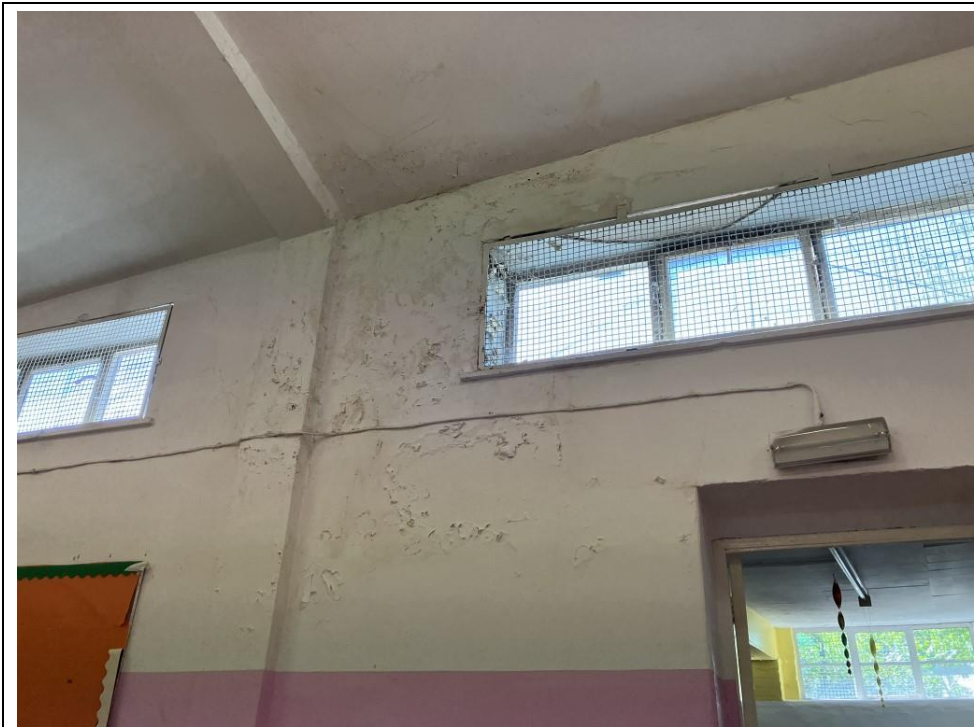
31. Ground floor central section, stained and flaking paint finish.

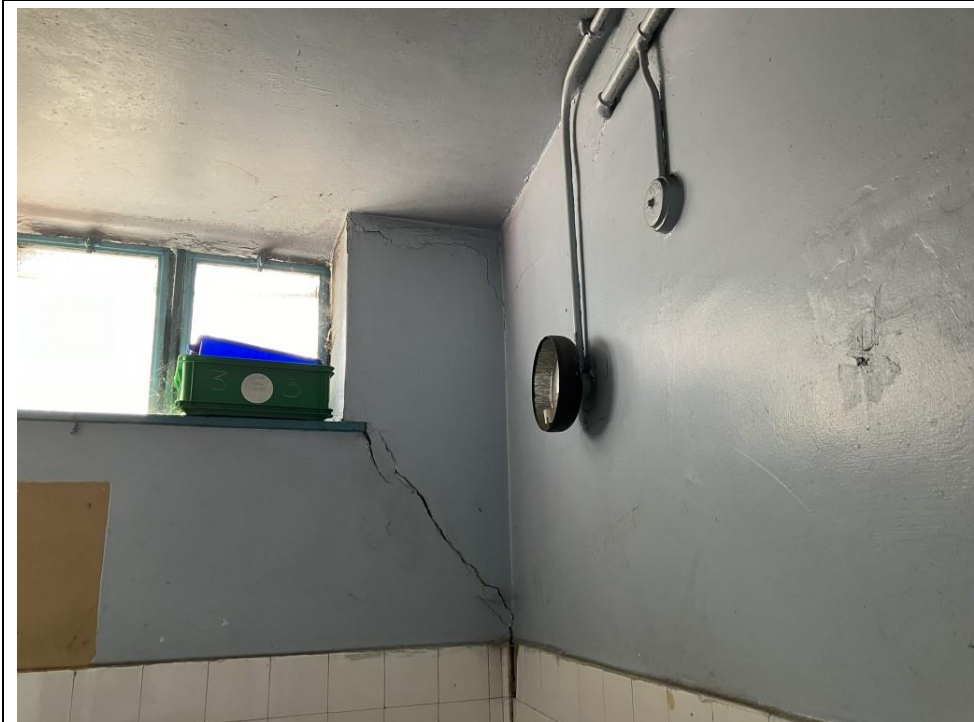
32. Ground floor central section, moderate crack.

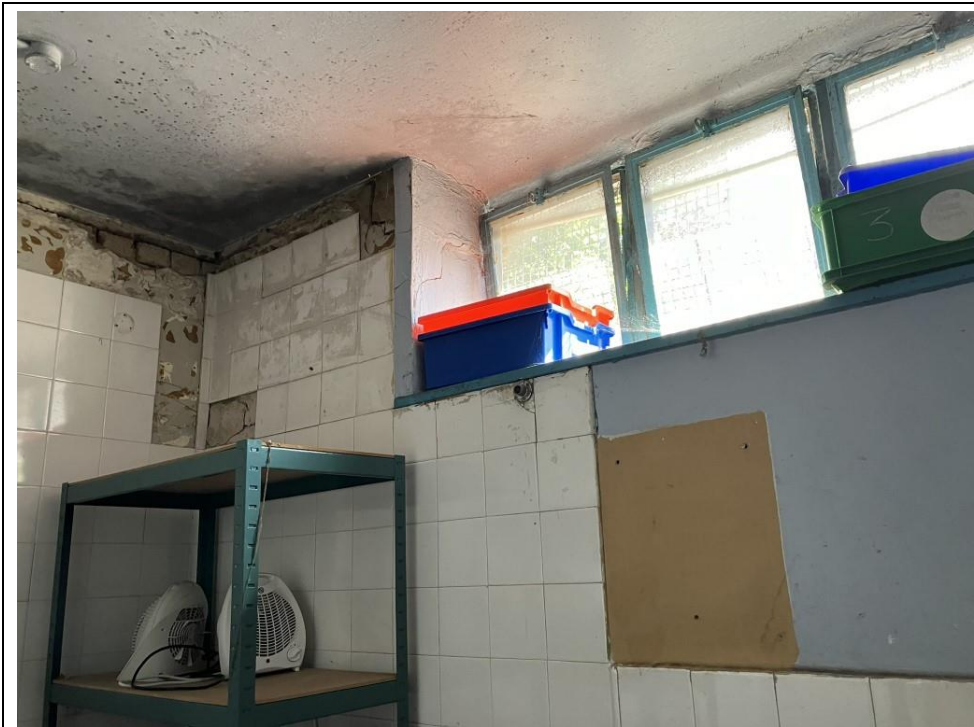
33. Ground floor central section, failed wall tiles.

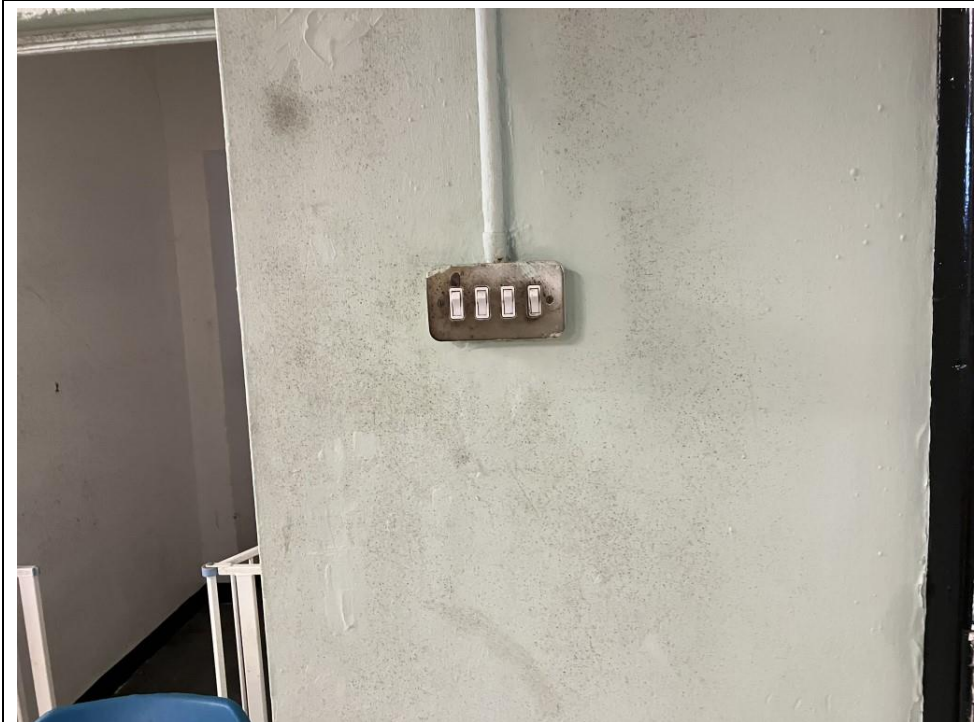
34. Ground floor west section, indicative mould growth.

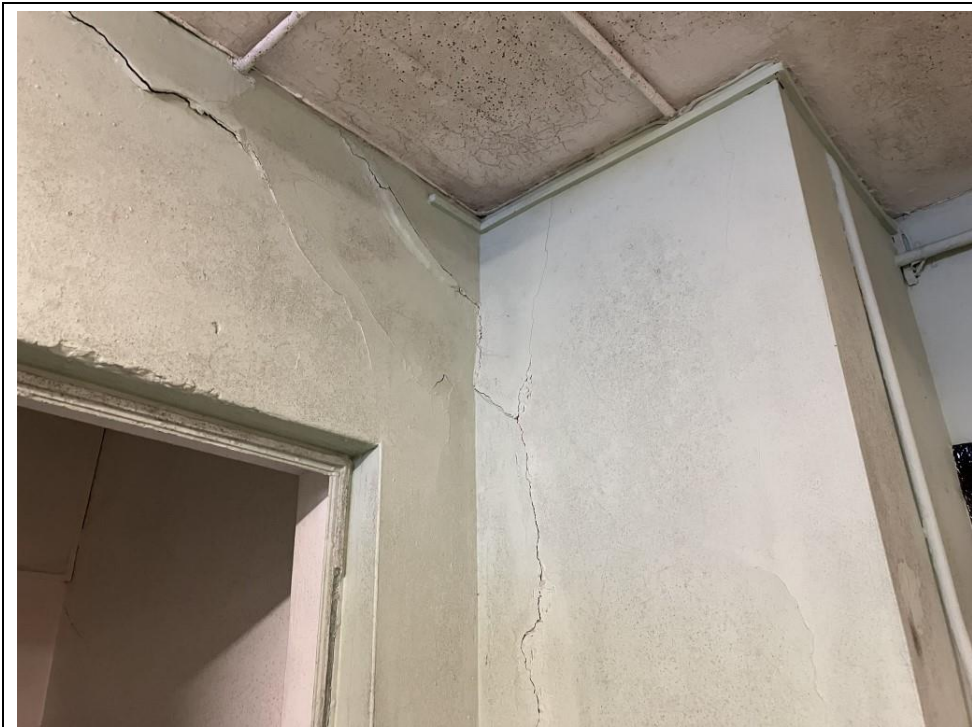
35. Ground floor west section, indicative mould growth and cracking.

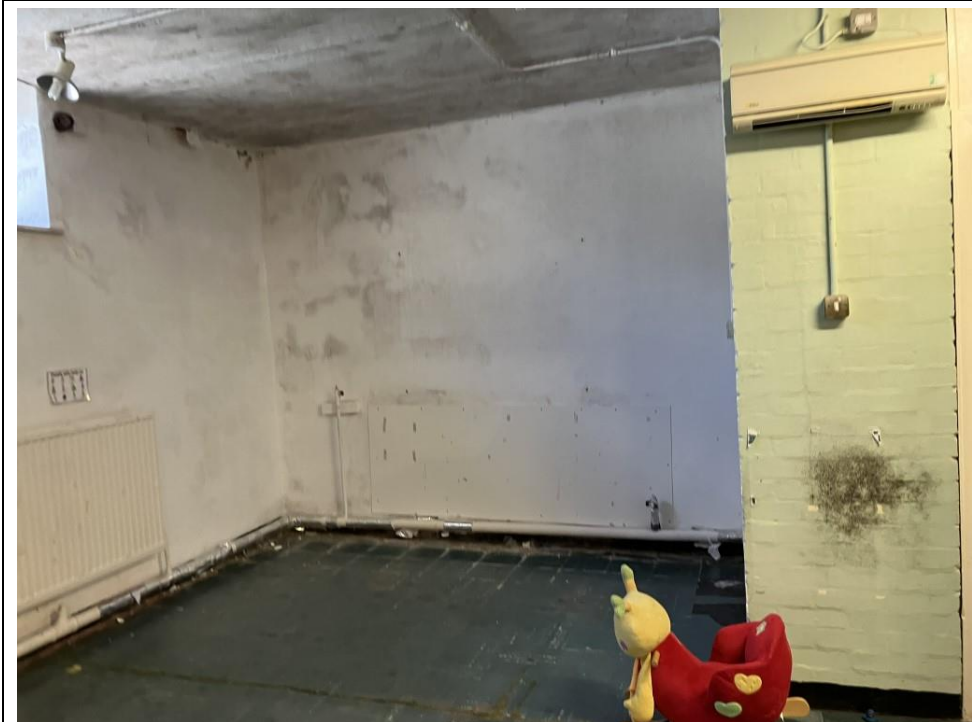
36. Ground floor west section, indicative mould growth and staining.

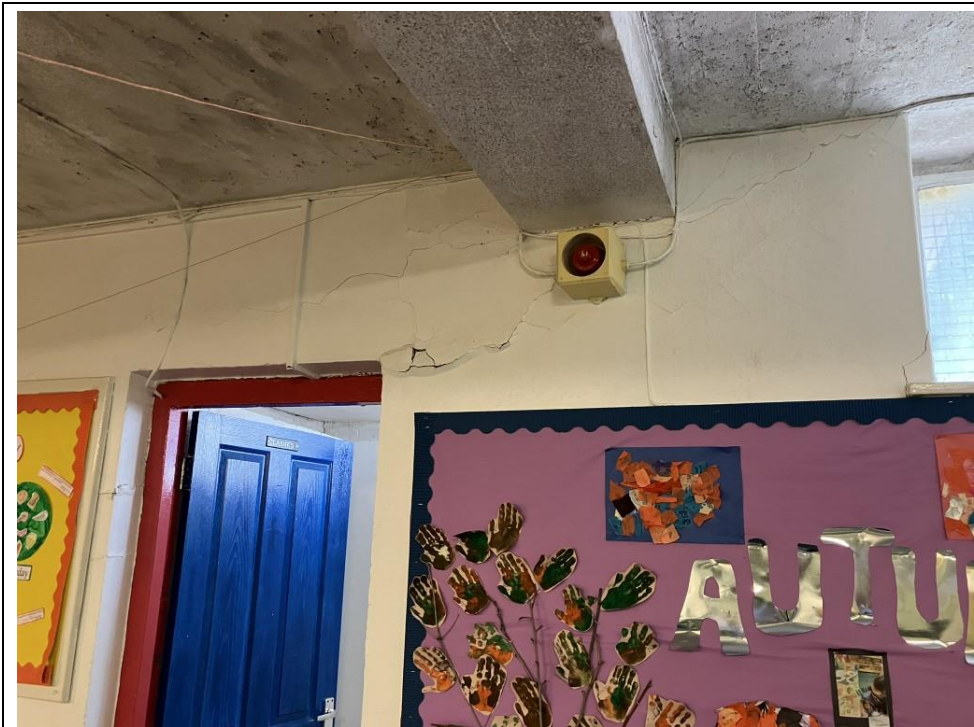
37. Ground floor west section, indicative cracking.

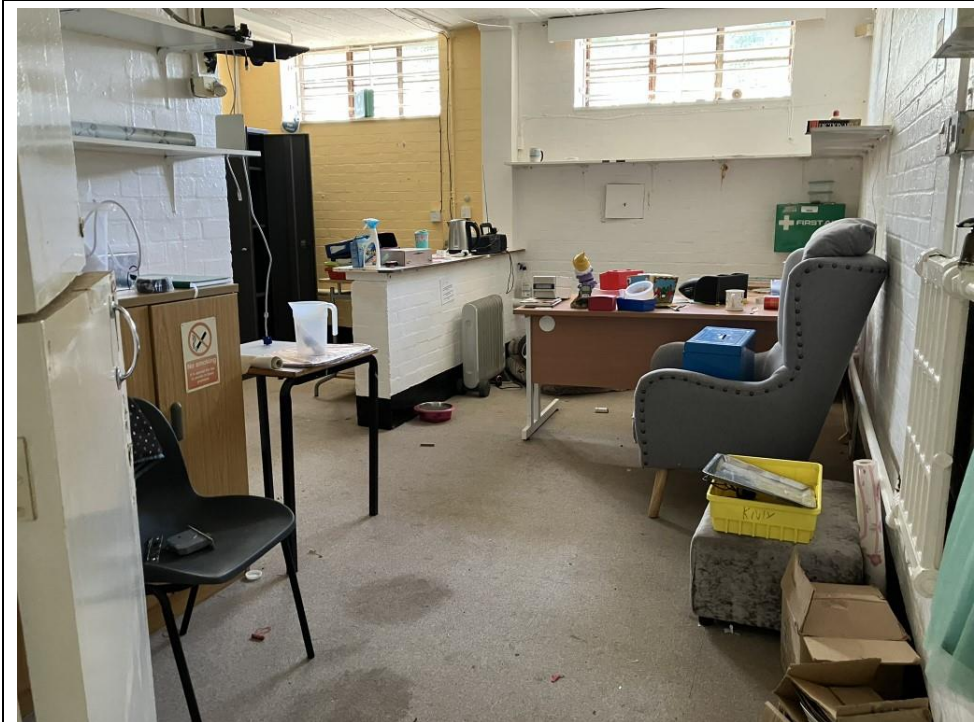
38. Ground floor east section, indicative carpet staining.

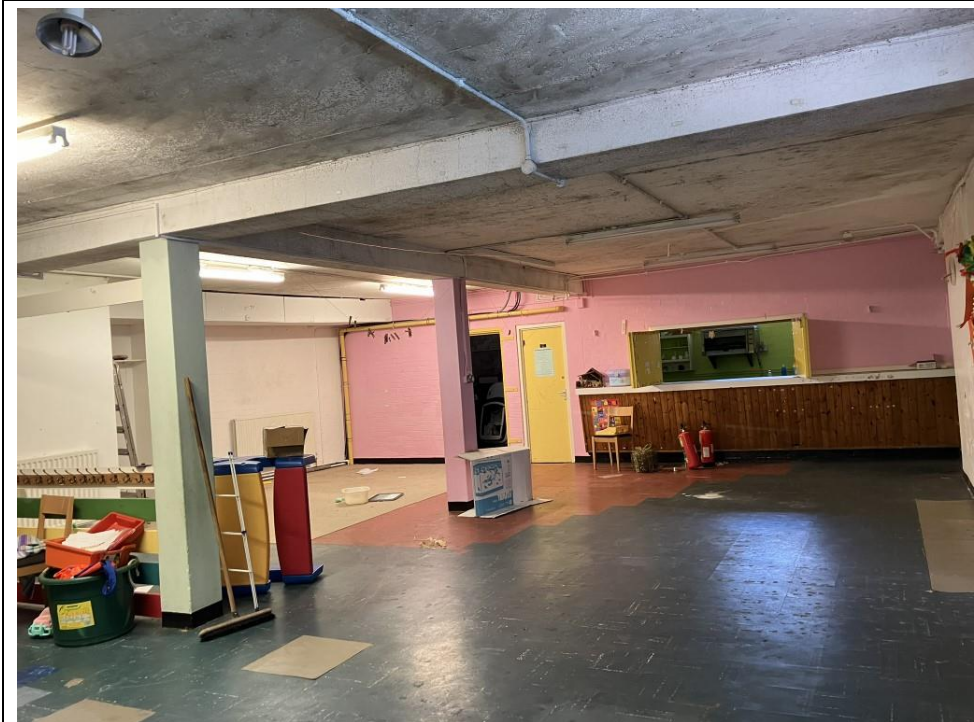
40. Ground floor west section, indicative mismatching floor.

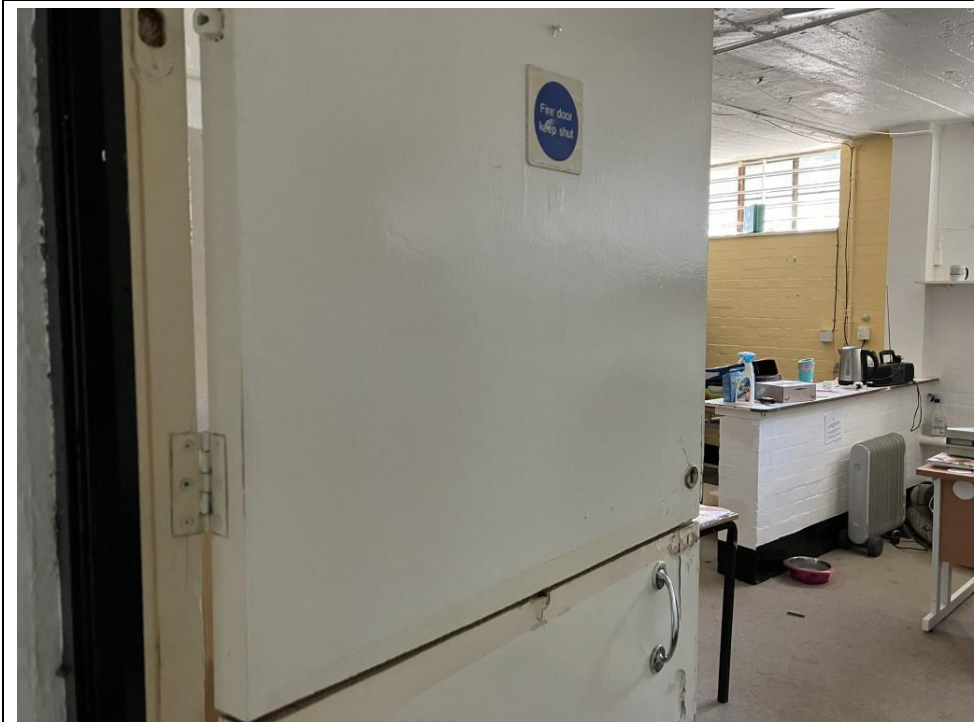
42. Ground floor east section, fire door compromised to form a "Dutch" Door.

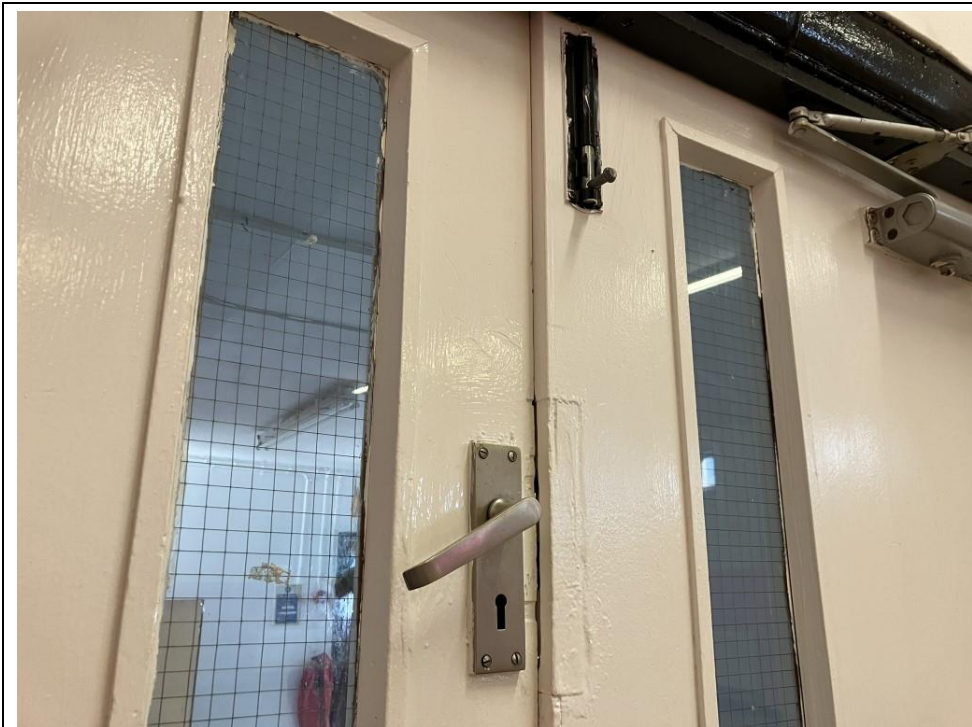
43. Ground floor central section, door ill fitting.

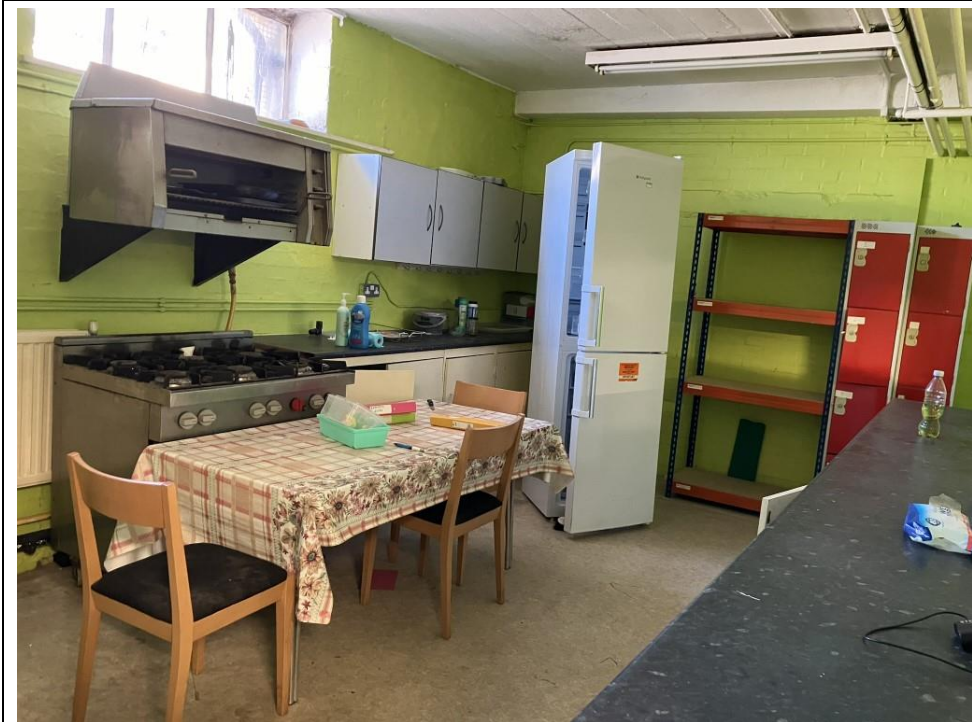
44. Ground floor west section, example of prior tenant's abandoned fittings.

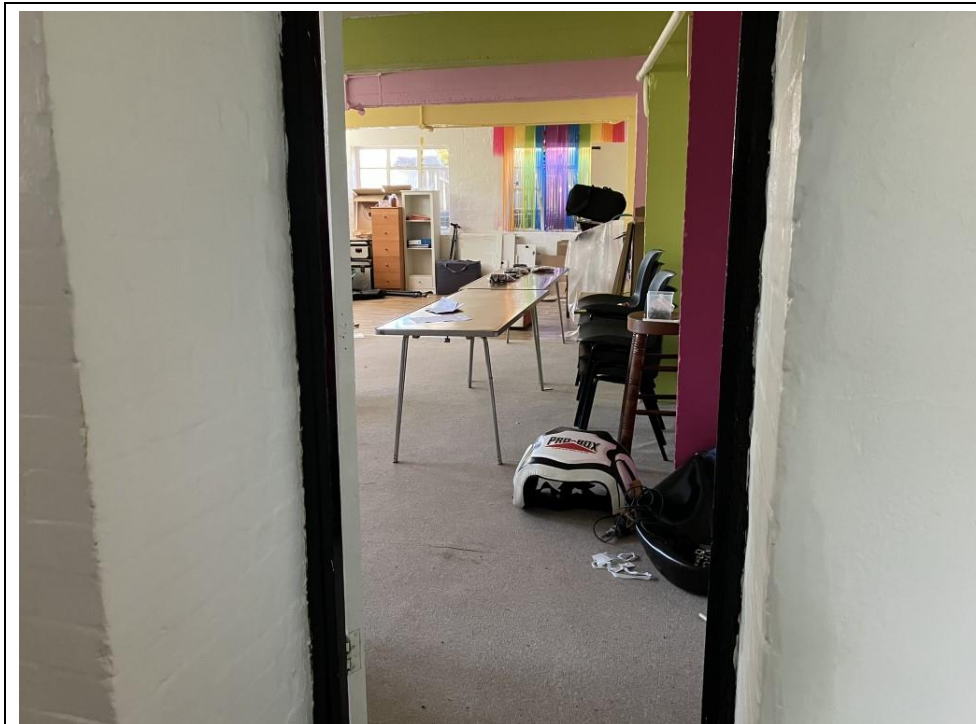
45. Ground floor east section, example of prior tenant's abandoned fittings.

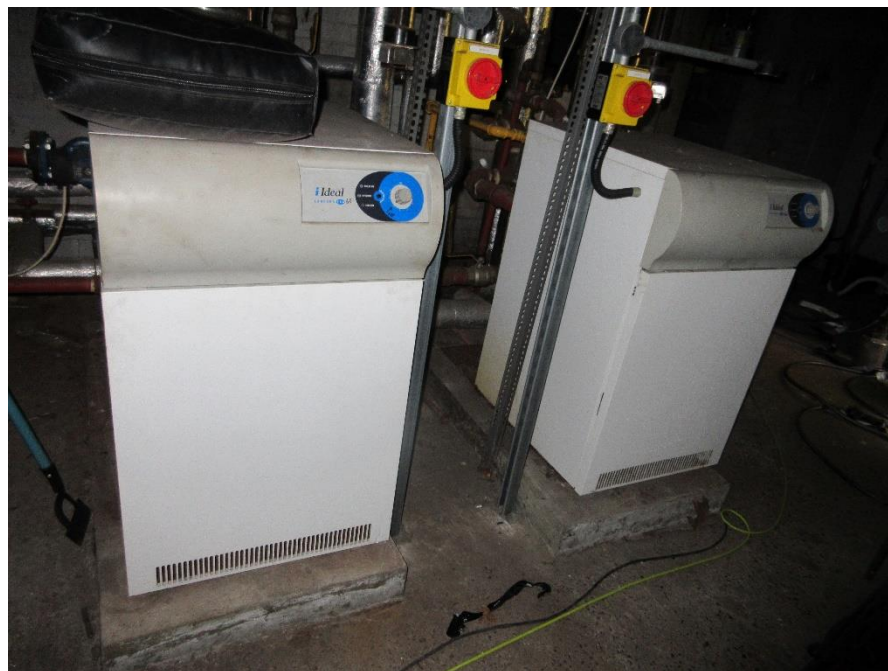
50. Gas fired boilers in the basement plant room, isolated and not operational at the time of our survey.
