Gladstone Park Community Centre Building Inspection Report

Gladstone Park Community Centre
162 Anson Road
London
NW2 6BH

Report Date
23 August 2024

Job Reference: 201777

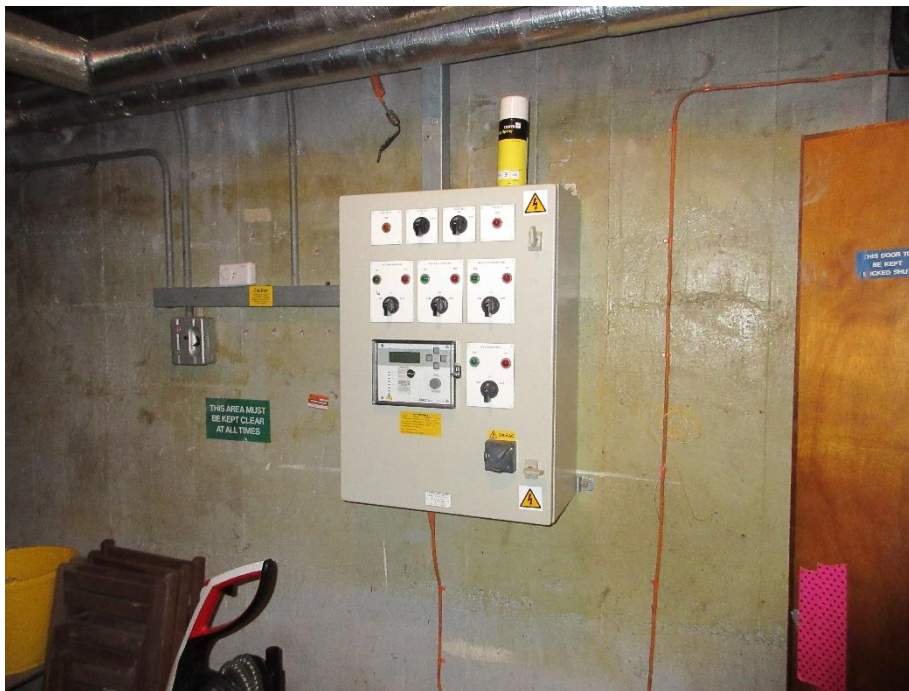
52. Control panel serving the mechanical services, all isolated.

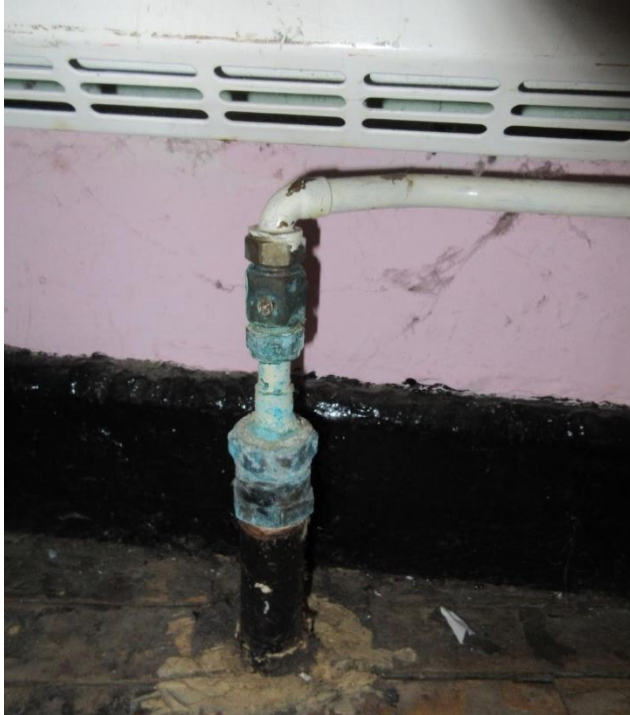
56. LTHW connections on the LST radiators are exposed and some are show signs of leaks / corrosion

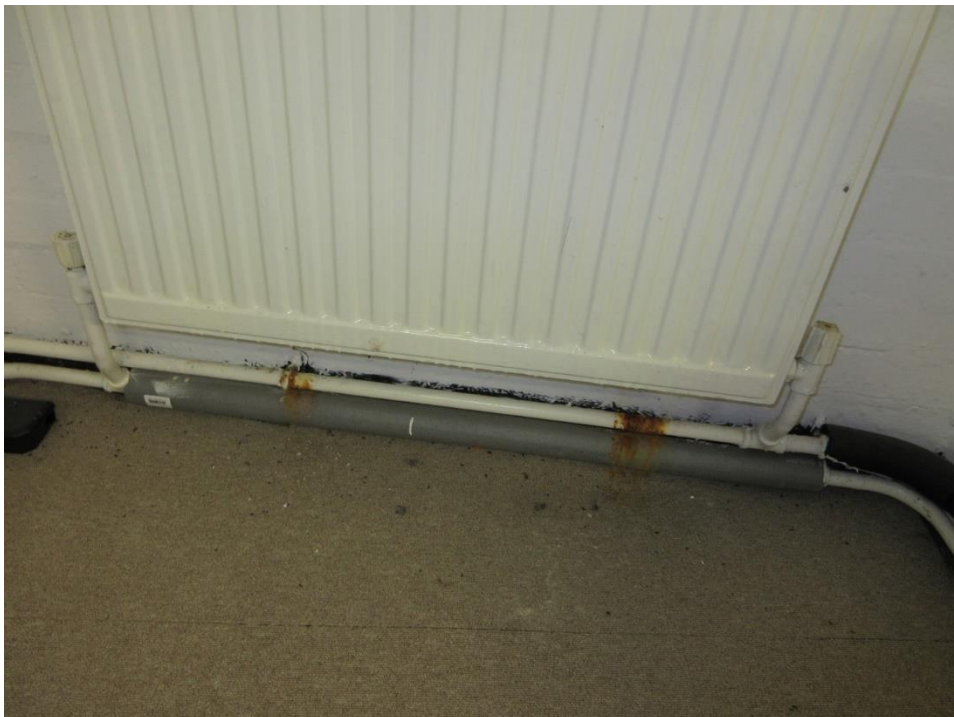
57. Other signs of leaks / corrosion on the LTHW system

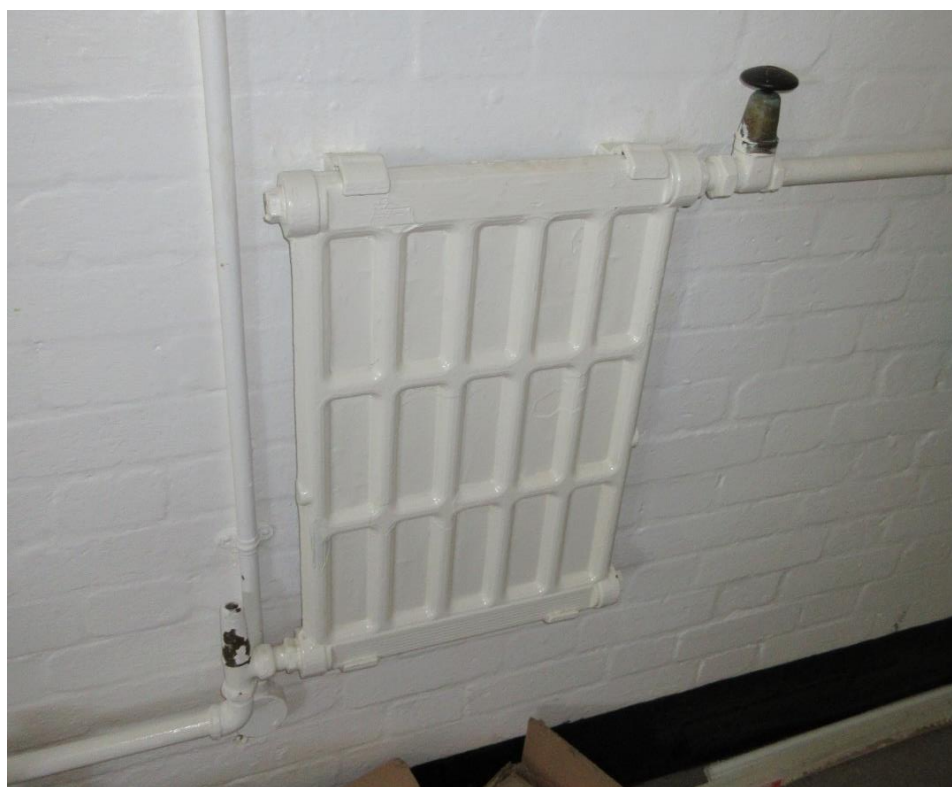
58. Aged cast iron radiator

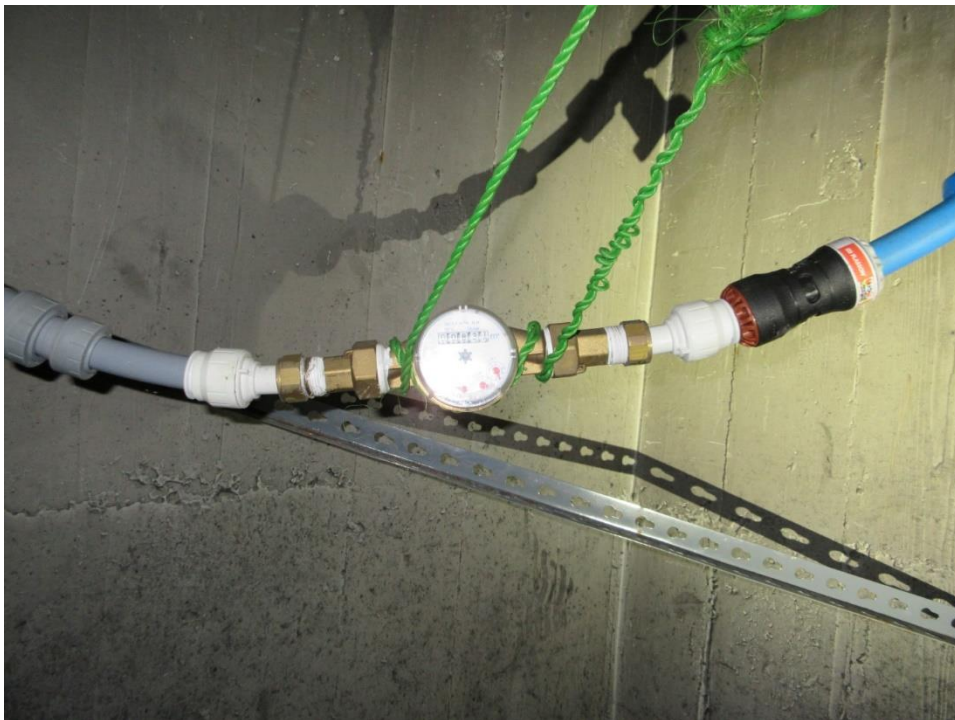
59. Poorly supported check meter on the mains water service at basement level, resulting in excessive pressure applied to connections

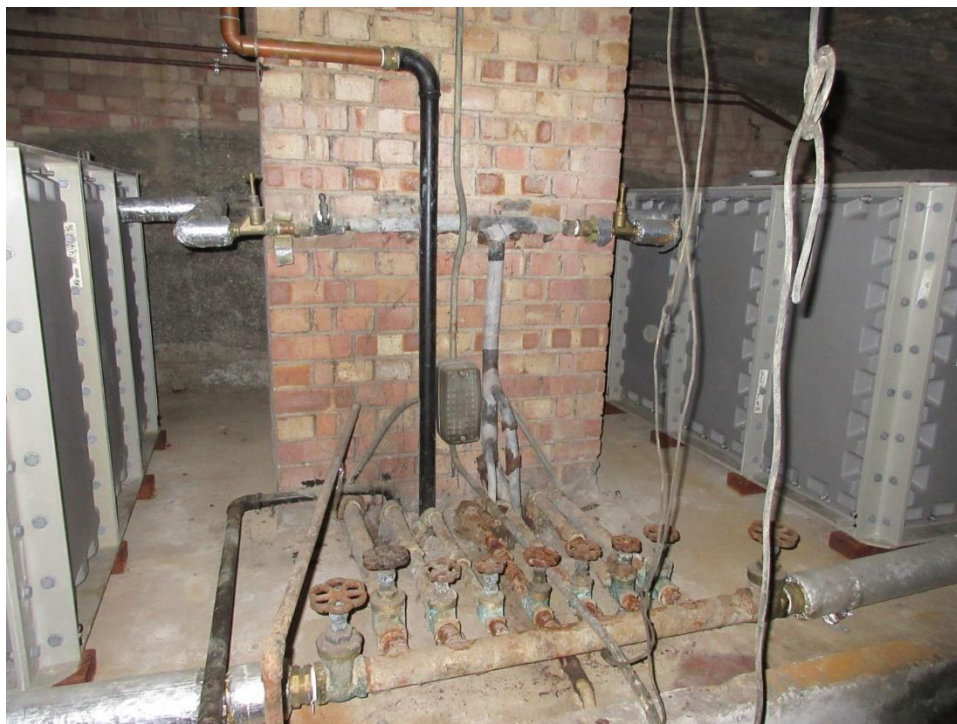
61. Mixture of pipework materials, lead, copper, steel

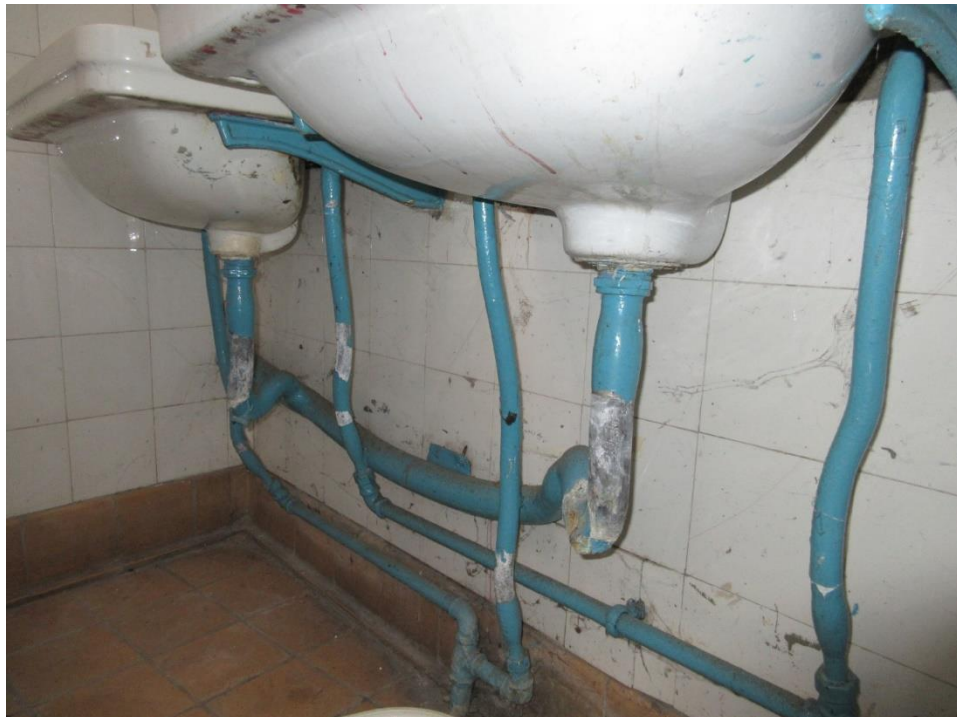
2	Some lead pipework is in use on the domestic water systems.	Replace lead pipe with either copper or multi layered plastic pipework to remove lead from the domestic water system.
1	Hot water is generated by a hot water Calorifier, we believe this is served by the LTHW system, however access to the hot water cylinder is limited and fully extent of the provision was not confirmed.	We recommend access to the hot water cylinder is improved to enable water sampling and/or routine temperature checks in compliance with ACOP L8 requirement
2	No thermostatic mixing valves seen, to limit the risk of scalding.	Carry out a risk assessment considering the user groups that will be in the property and provide TMV's as required/recommended.

62. Lead pipework on the domestic and waste services. Waste pipe is unsupported and now not laid to a fall

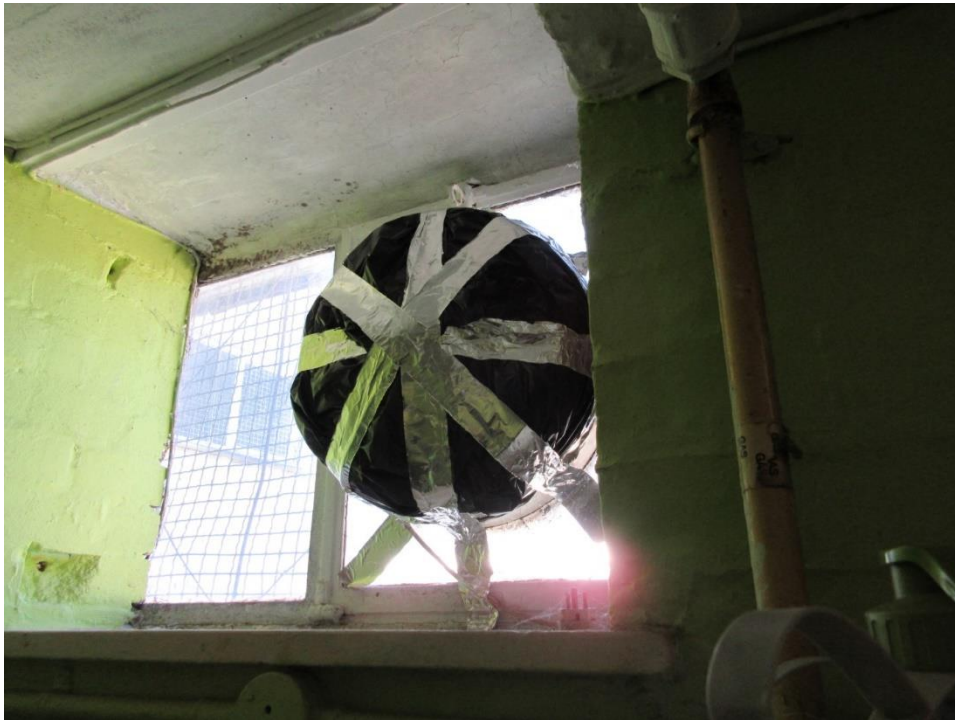
63. Kitchen extract fan is isolated and temporarily covered

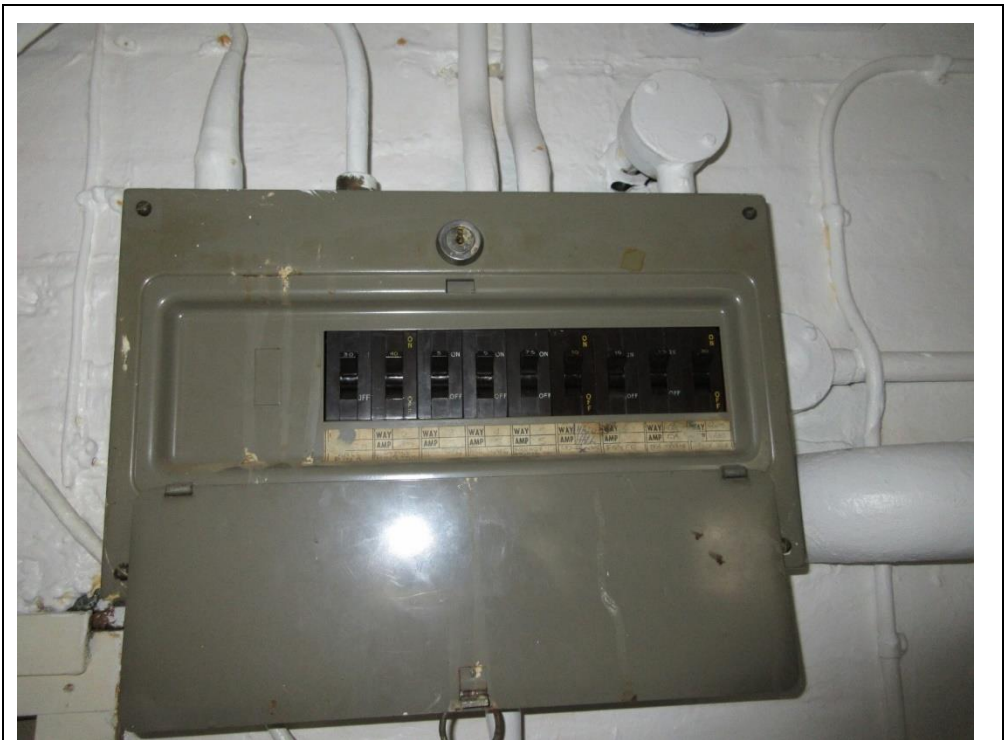
65. Typical aged distribution board, no circuit schedule

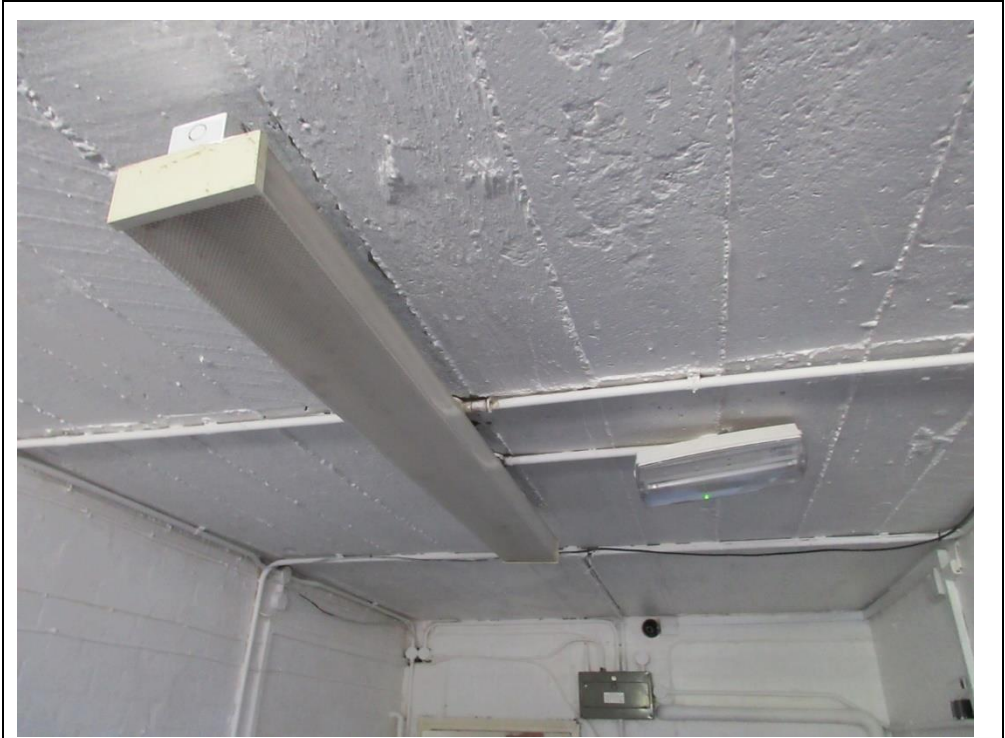
66. Typical aged fluorescent lighting and emergency lighting

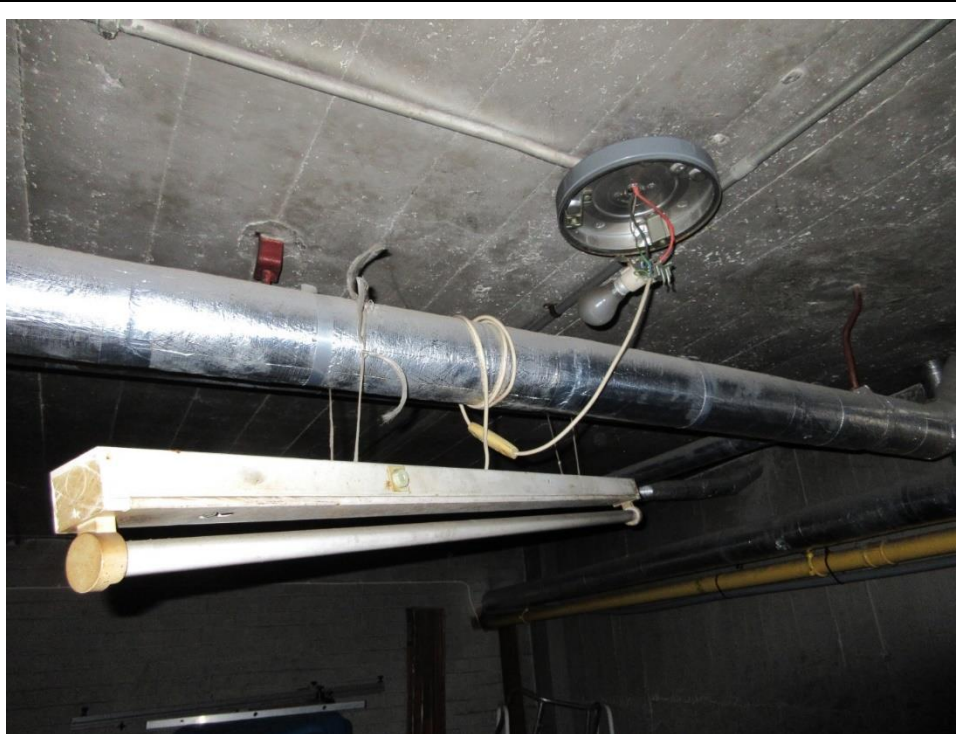
67. Typical poor lighting modification / repair on site

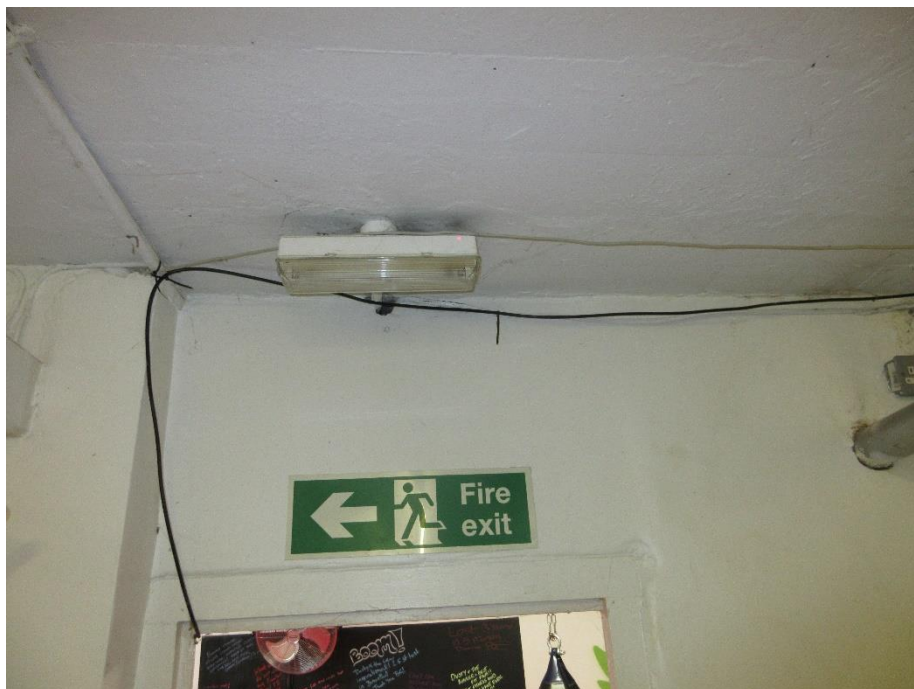
68. Typical emergency light, emergency lighting and signage should be reviewed on site and additional service provided where required
