**Report for London Borough of Brent**  
Kilburn Library, Salusbury Road, London NW6 6NN

Accessibility Audit

05 September 2022

Prepared By: Sam Crowe MRICS

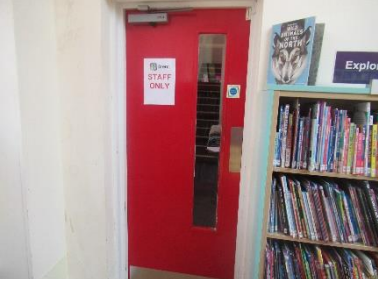
14	Fire escape doors	The staff access doors serves as a fire escape door and has been reported above.	n/a	n/a	n/a

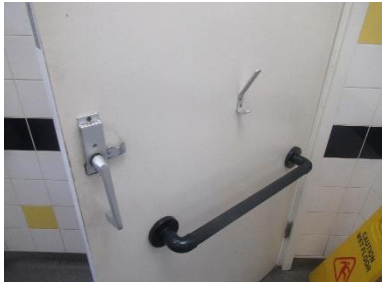
<p><b>15</b></p>	<p><b>Door furniture</b></p>	<p>Door furniture comprises a combination of lever handles, pull handles and digilocks. All are located within correct tolerances</p>	<p>No action required</p>	<p>n/a</p>	<p>n/a</p>

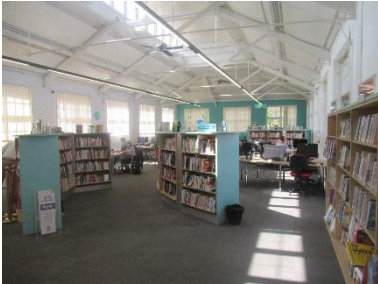
<p><b>16</b></p>	<p><b>Overhead door closers</b></p>	<p>Overhead door closers are provided throughout and generally acceptable</p>	<p>No action</p>	<p>n/a</p>	<p>n/a</p>	<p>n/a</p>
<p><b>17</b> i</p>	<p><b>General circulation</b> Ground floor</p>	<p>Library space is very open plan with no fixed corridor or designated circulation space.  Shelving is used to create zones between areas and clear widths are in excess of 1.8m</p>	<p>No action</p>	<p>n/a</p>	<p>n/a</p>

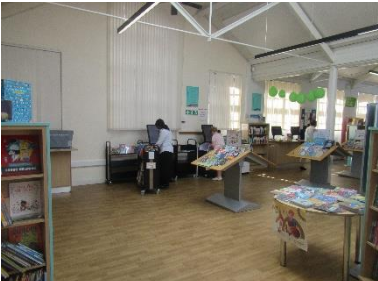
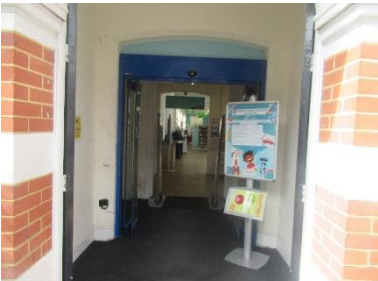
18 i	<b>Floor surfaces</b> Ground floor and mezzanine	<p>Flooring is a combination of carpet tiles and timber effect sheet vinyl.</p> <p>Safety vinyl is provided to the Accessible WC</p> <p>Barrier mat to main entrance and fire exit lobbies is multi directional and suitable for wheelchairs.</p>	<p>No action</p> <p>No action</p>	n/a	n/a

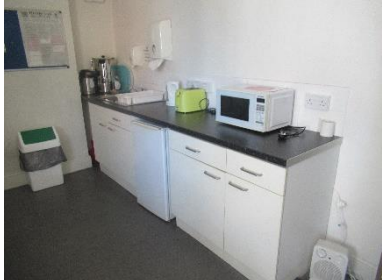
ii	First floor and mezzanine	<p>Carpet tiles provided throughout</p> <p>Sheet vinyl has been used to the staff room/ kitchenette and WC.</p>	No action required	n/a	n/a

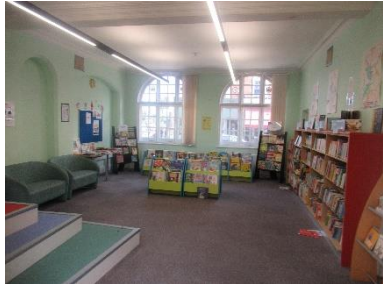
19	<b>Lighting</b>	<p>Lighting comprises suspended LED light fittings which have been recently fitted as part of an energy saving programme.</p> <p>Lights benefit from daylight sensors and adjust to the correct LUX levels as required.</p>	No action	n/a	n/a

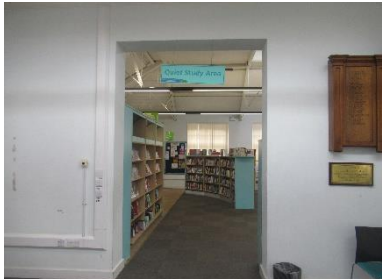
20	<b>Electrical socket/outlets/light switches etc</b>	<p>Floor sockets are mounted at varying heights either floor level or 450mm above finished floor level. These are for permanent fittings or staff use only. Dado trunking is provided to ICT areas for public/ teaching PCs</p>	No action required	n/a	n/a

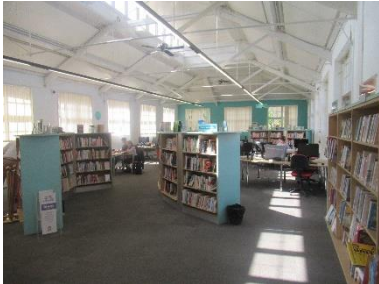
Light switches, where present are mounted between 1100 – 1250mm AFFL.				
<b>21</b>	<b>Acoustics</b>					
i	Generally	The library is a double height space with carpet floor finishes and shelving with books throughout. Generally the reverb time was deemed acceptable.	No action.

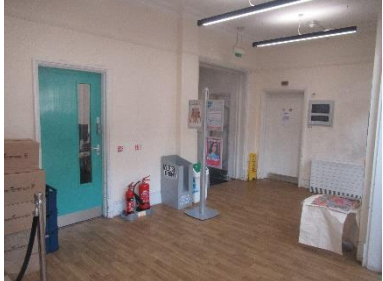
Horizontal escape	Ground, ground mezzanine and first floor have a clear and unobstructed route to a place of safety.	No action	£0.00	E
