Brent

Highways Committee

**Report from the Head of
Transportation**

Petition for Road Improvements in Tanfield Avenue

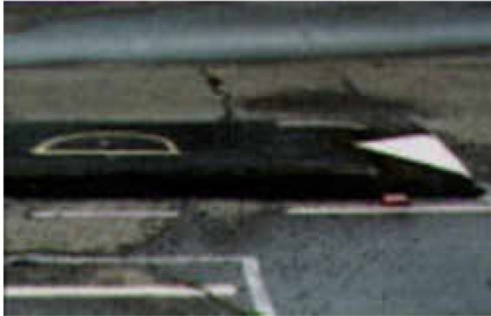
Speed cushion installed at test site

The following types of road humps were tested:

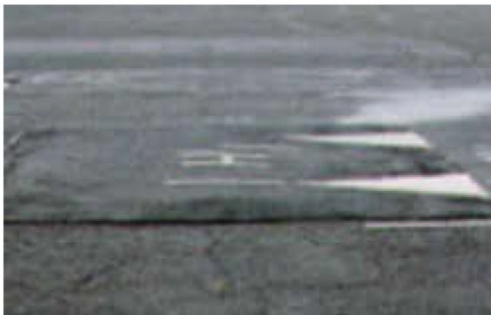
A round top hump 65mm high

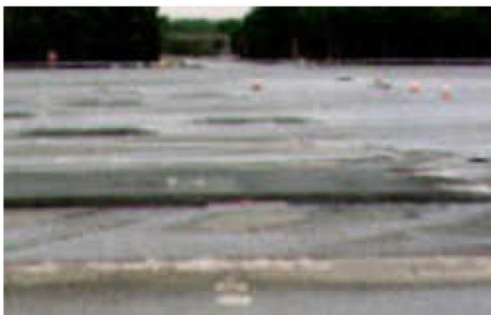
A flat top hump 75mm high

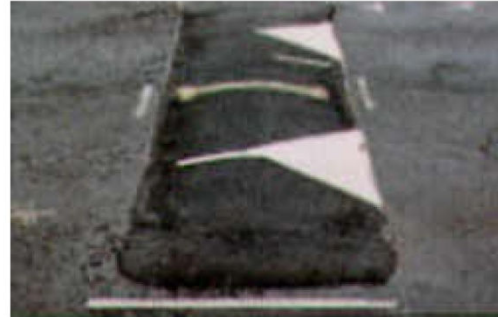
A "thump" (short hump) above the recommended height for this feature at around 75mm high, was used to examine the effect of a harsh profile on vibration generation

As with previous studies, it was found that there was a tendency for vibrations to increase with increases in speed. For a given crossing speed the 74mm high "thump" generated the highest levels of vibration recorded during the study. The long flat top road hump also had high vibration levels relative to the other road hump types, though much lower than the "thump". The narrowest cushions gave results similar to each other, causing the least generation of vibration.
