Gladstone Park Community Centre Building Inspection Report

Gladstone Park Community Centre
162 Anson Road
London
NW2 6BH

Report Date
23 August 2024

Job Reference: 201777

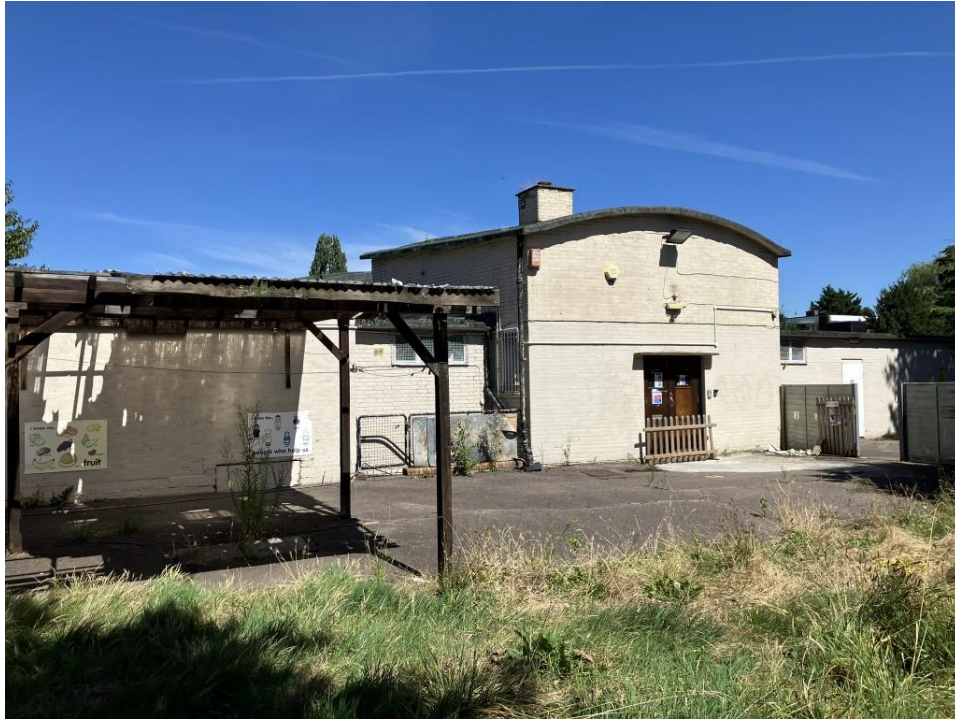
1. Front elevation. The “east” section is to the left, the “central” section is in the middle and the “west” section is to the right.

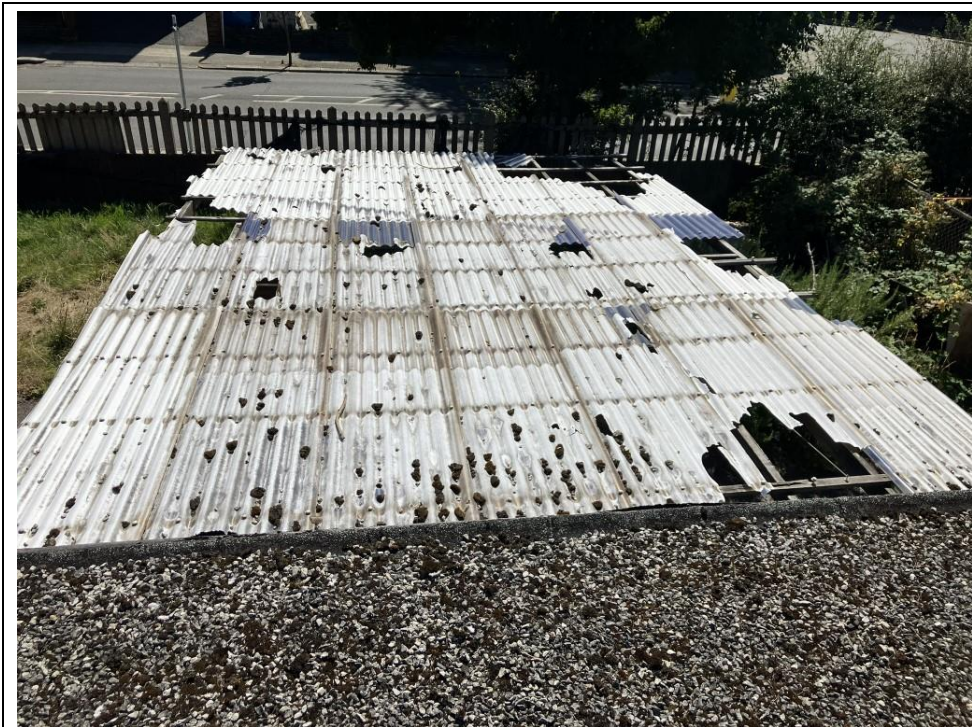
2. Projecting canopy PVC roof to front elevation east section.

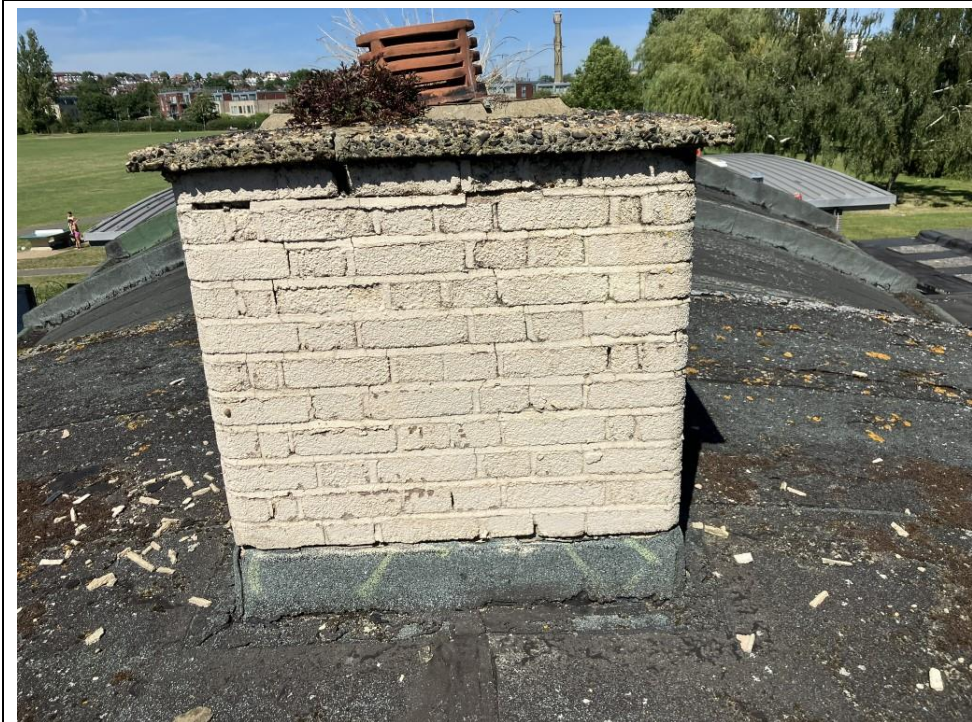
7. Central section, chimney.

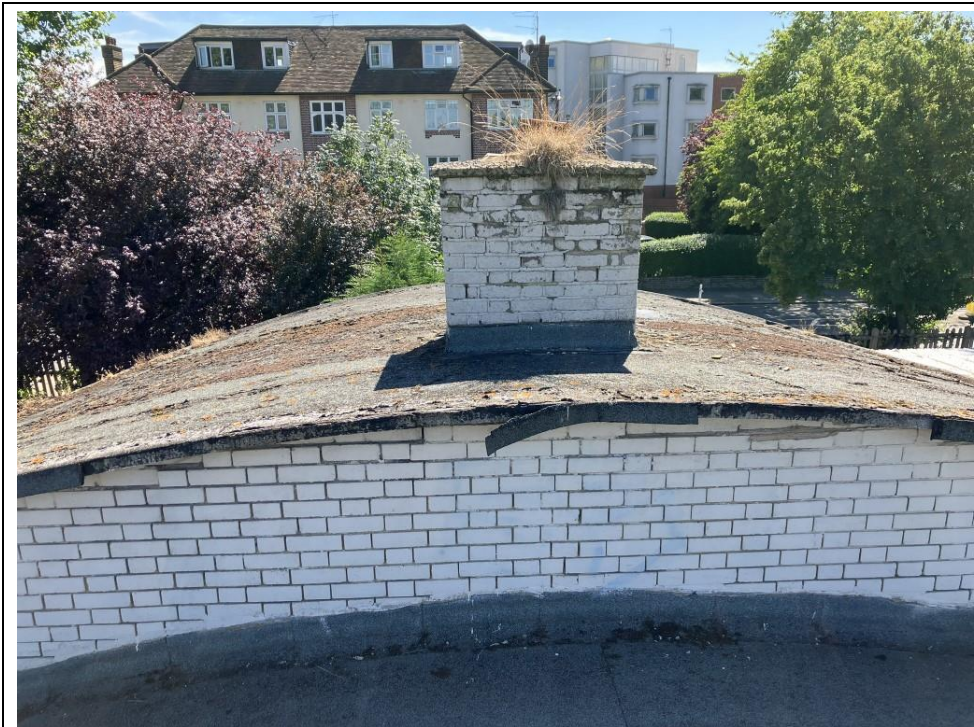
8. Central section, chimney.

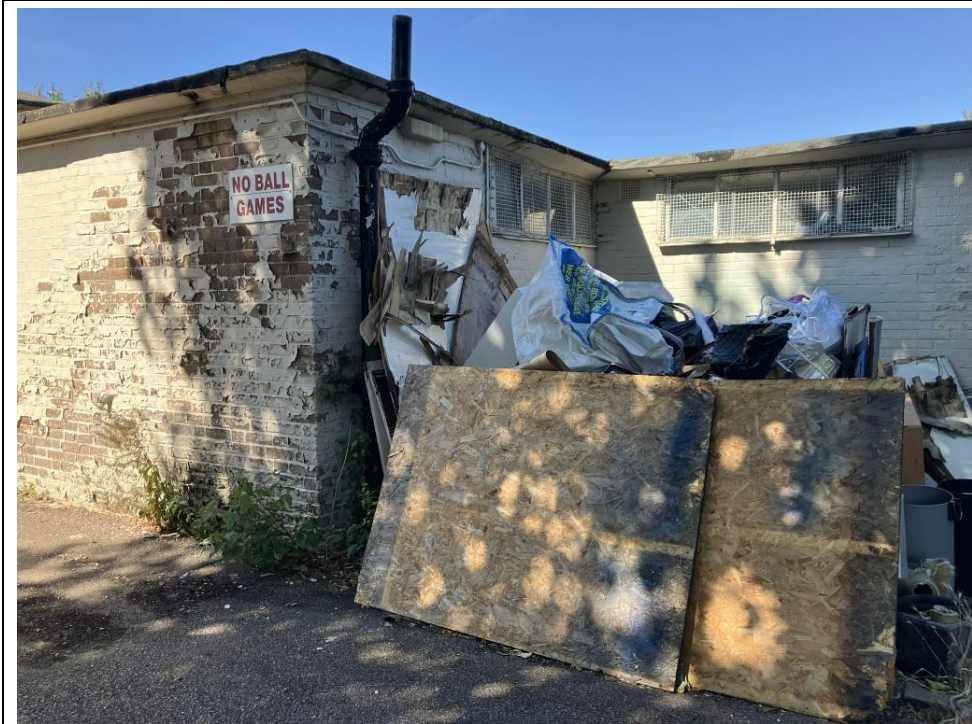
11. Front elevation east section.

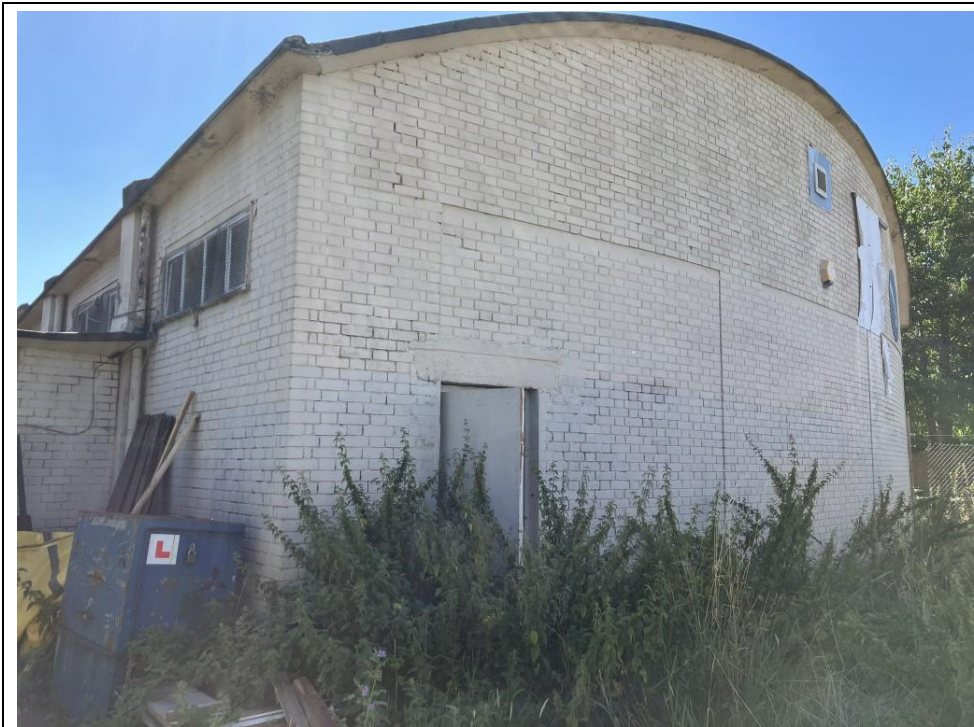
12. Rear elevation central section and rear emergency exit door.

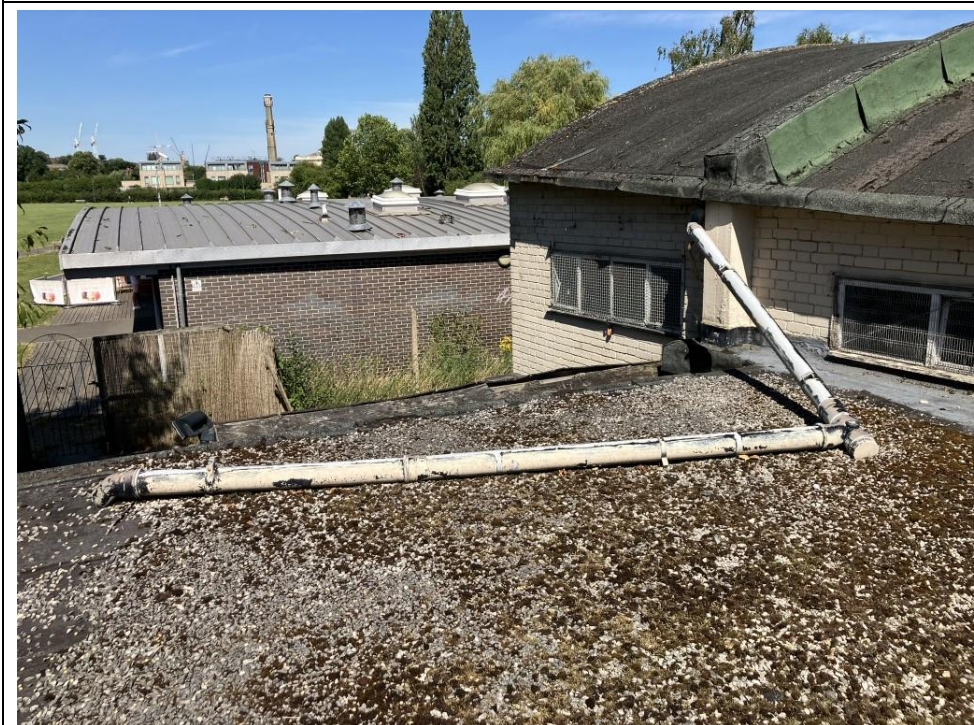
16. East section (roof level), PVC pipework.

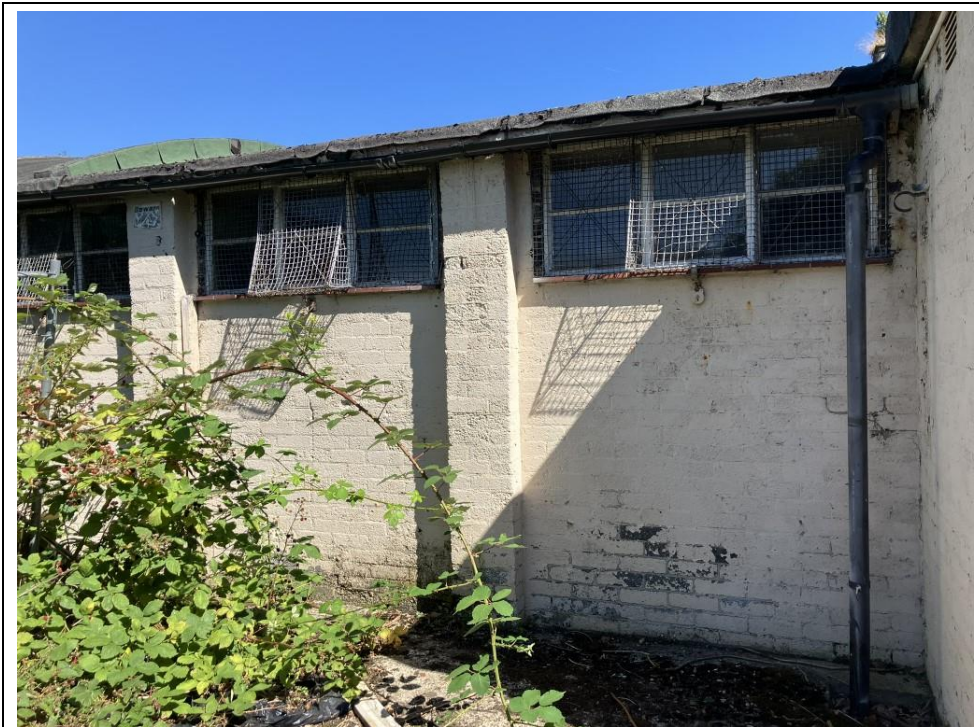
17. Side (left) elevation east section, PVC gutting and window grilles.

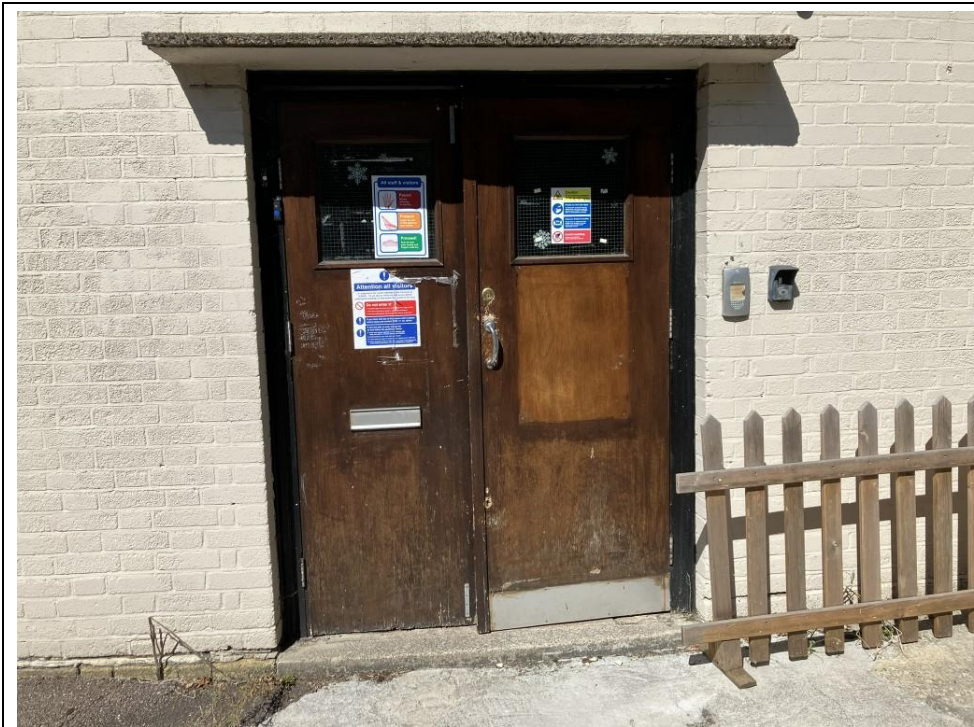
19. Front elevation central section, main access doors.

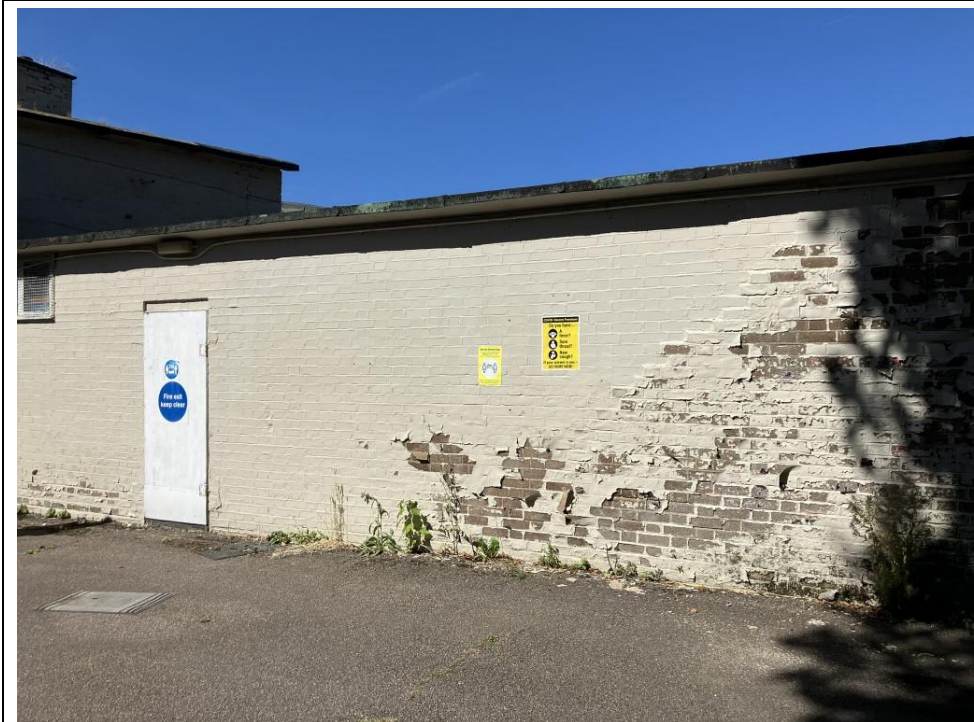
20. Front elevation west section, emergency exit door.

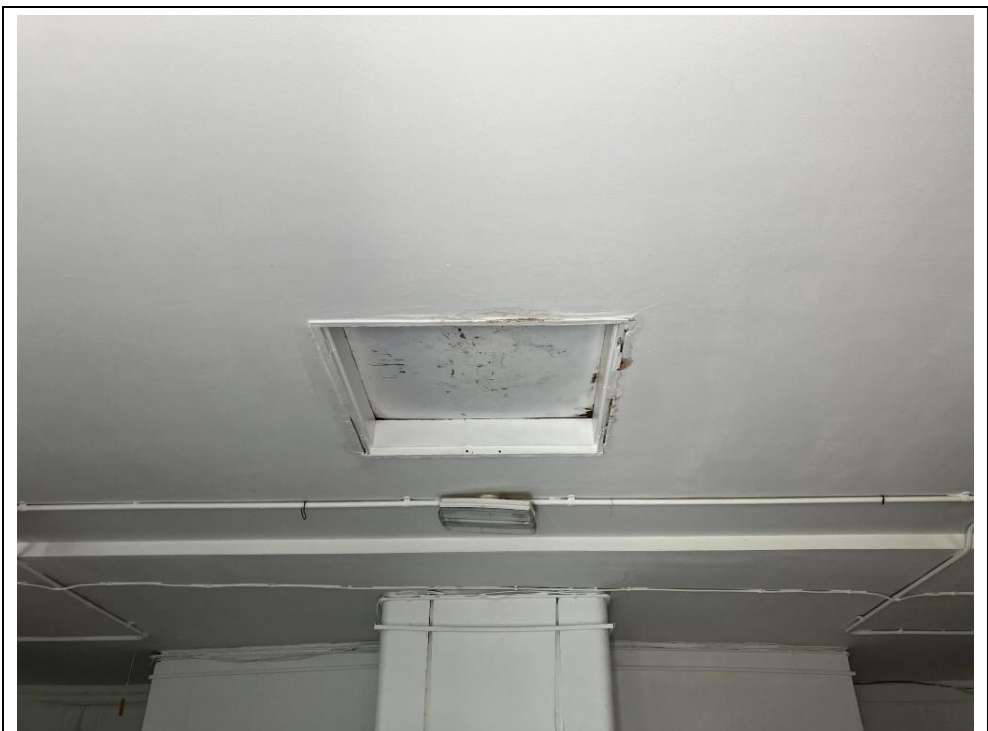
21. Central section, Loft access hatch to entrance foyer.

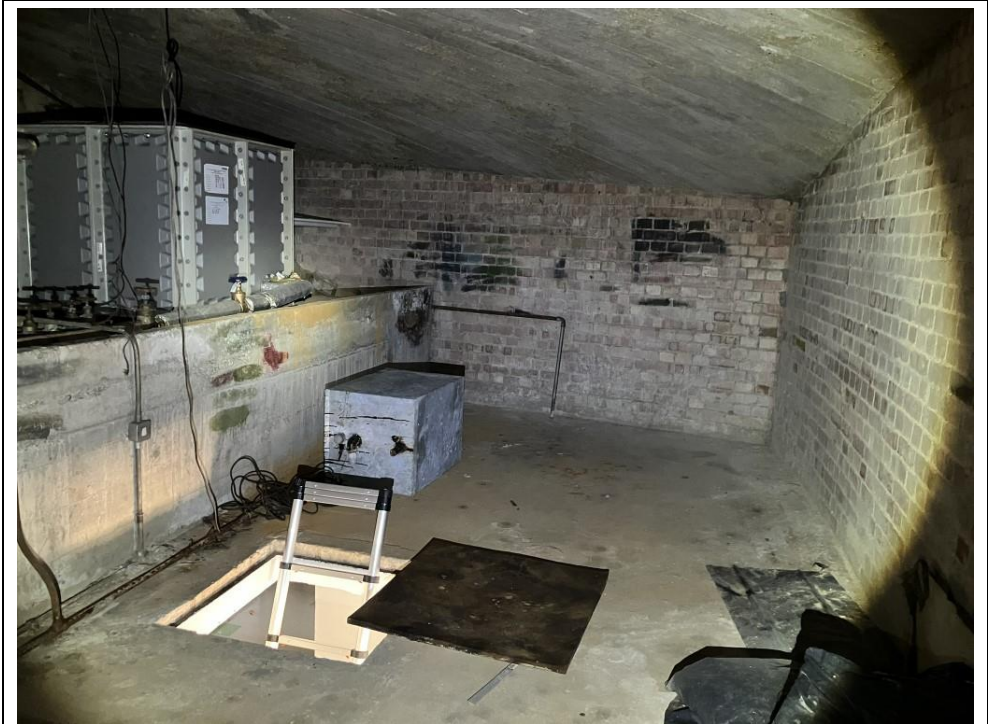
22. Loft space.

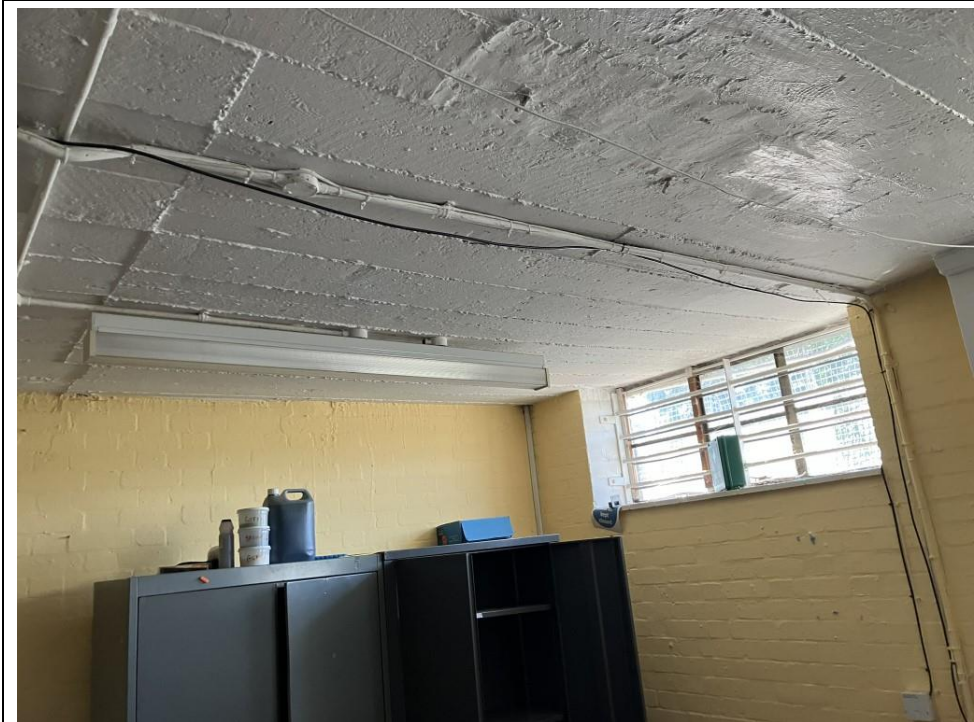
24. Ground floor east section, typical painted concrete board ceiling.

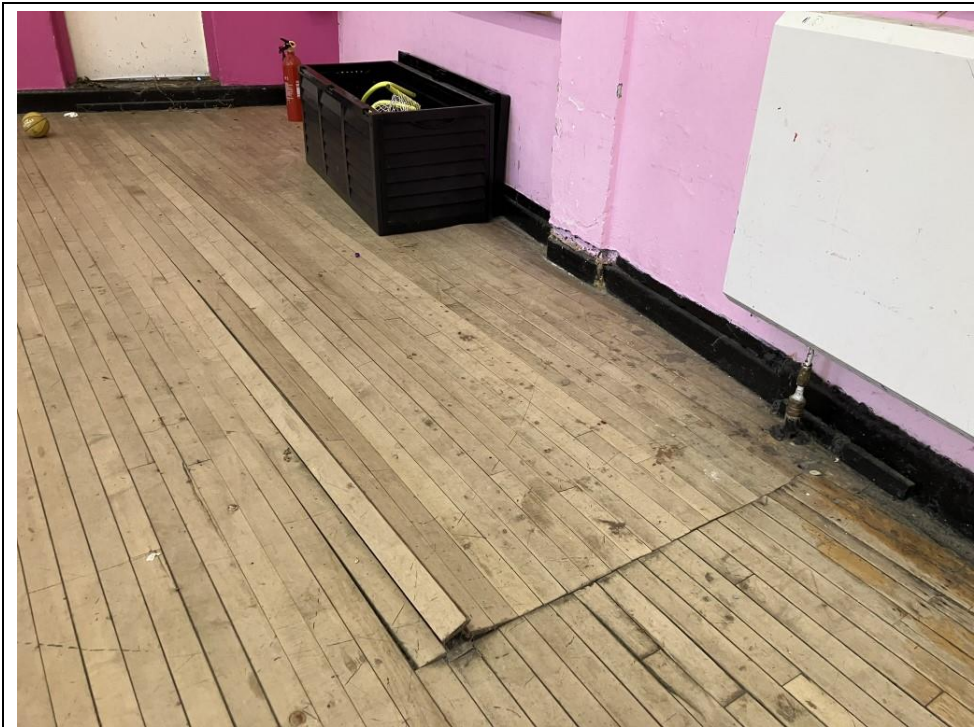
39. Ground floor central section, timber floor.

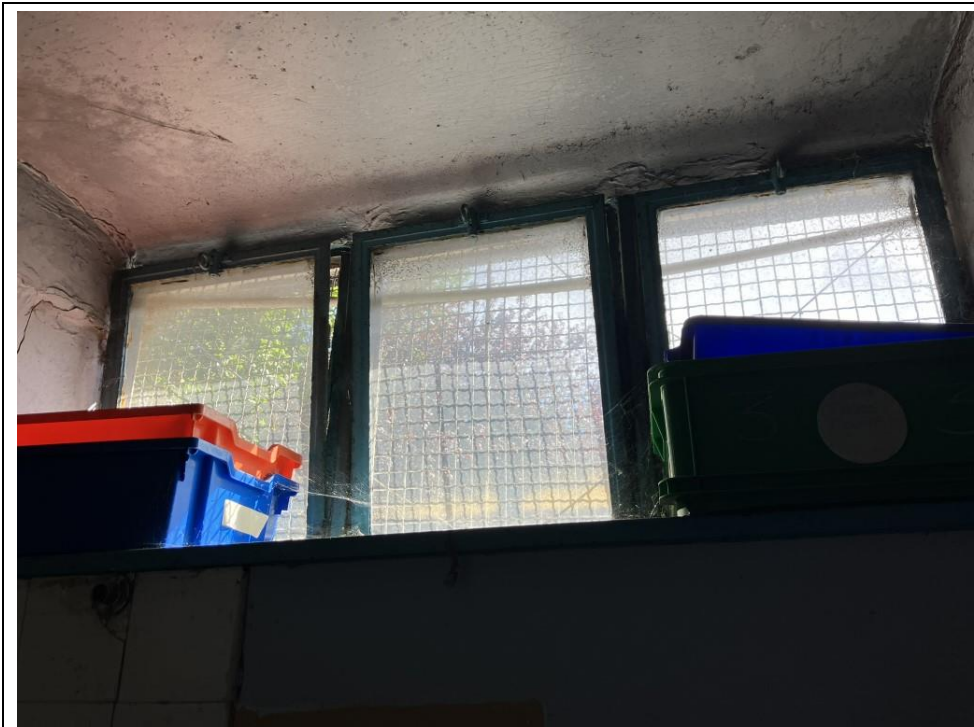
41. Ground floor central section, typical Crittall style window.

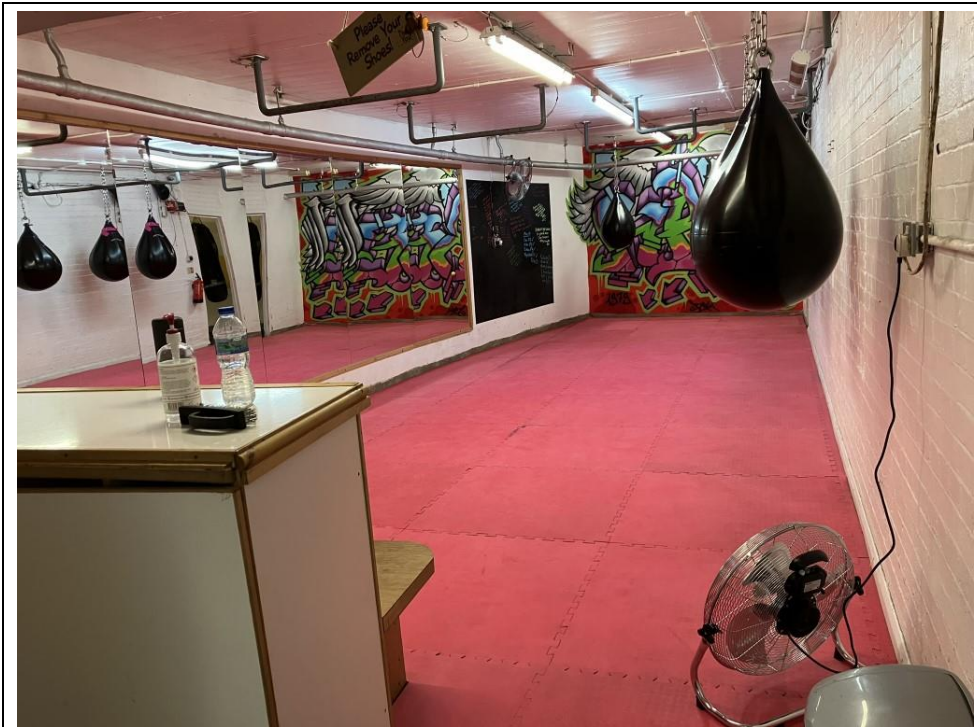
49. Basement, indicative condition photo.

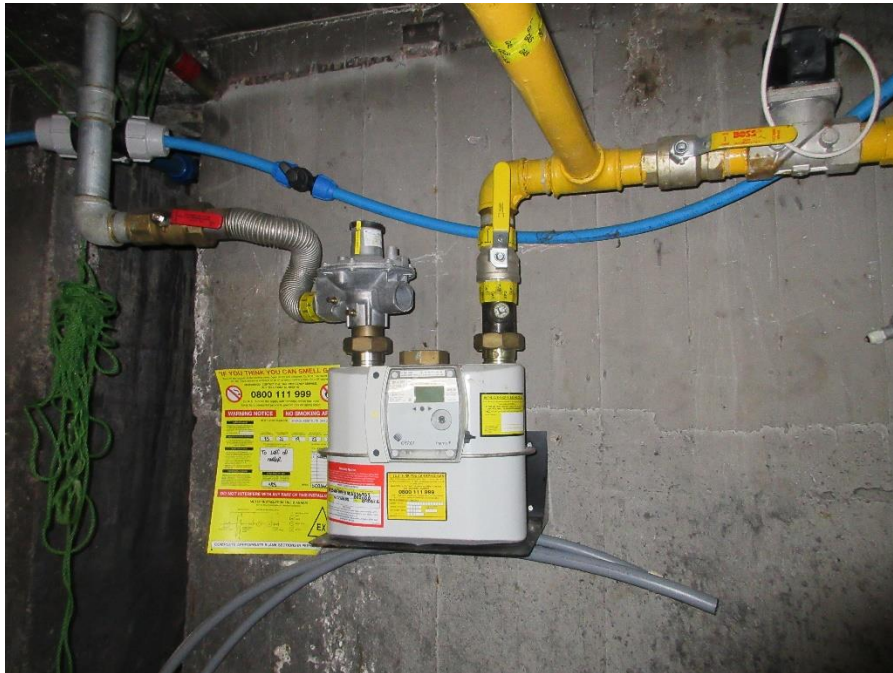
51. Incoming gas service, utility meter and solenoid valve within the basement plant room.

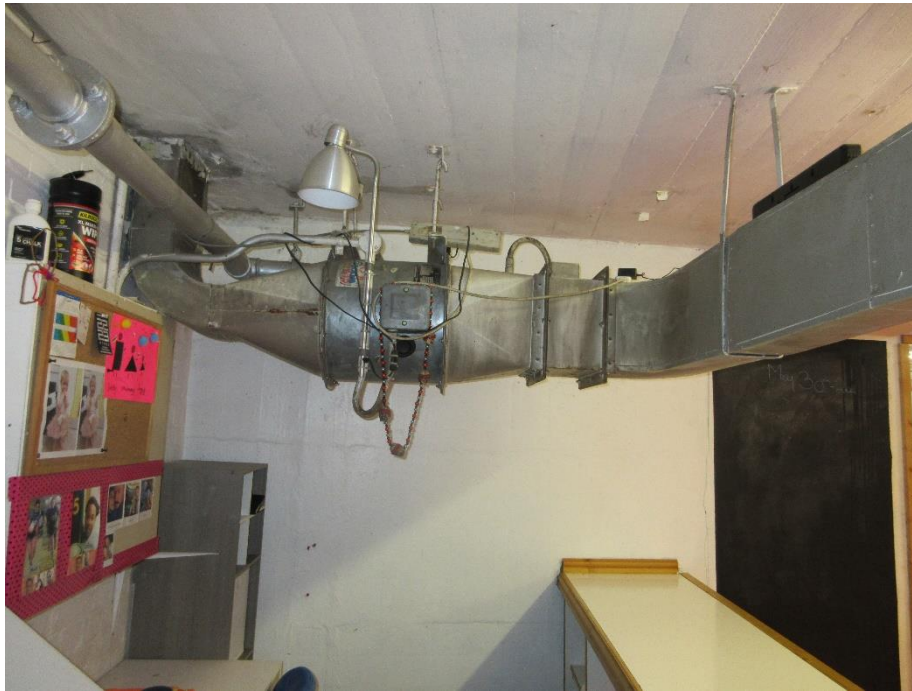
53. Extract fan serving the basement

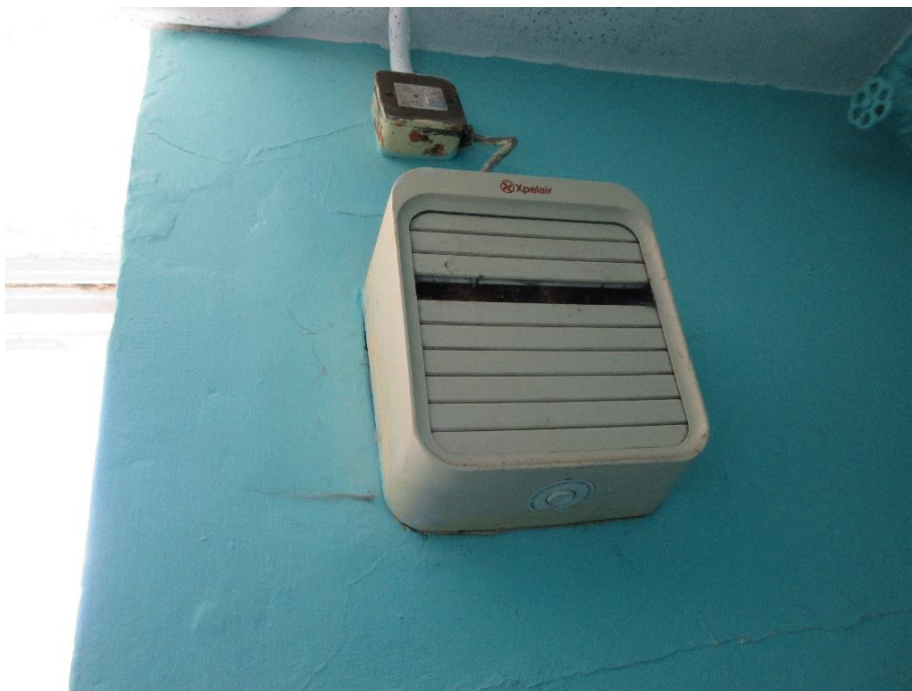
54. Extract fan serving the WC

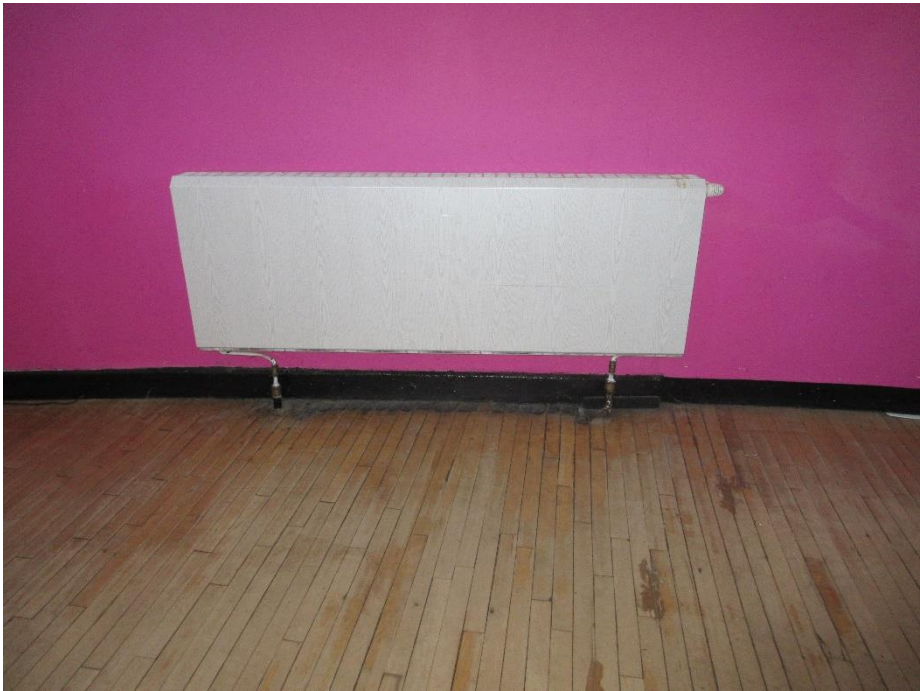
55. Typical radiator in the main hall, provided with LST cover

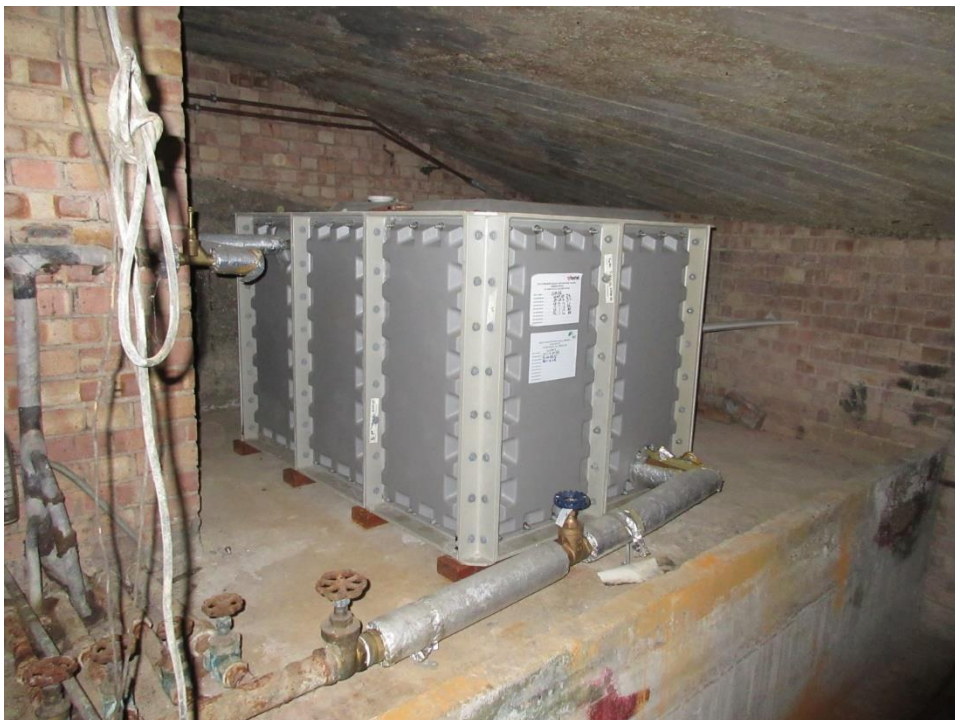
60. Cold water storage tank in the roof void

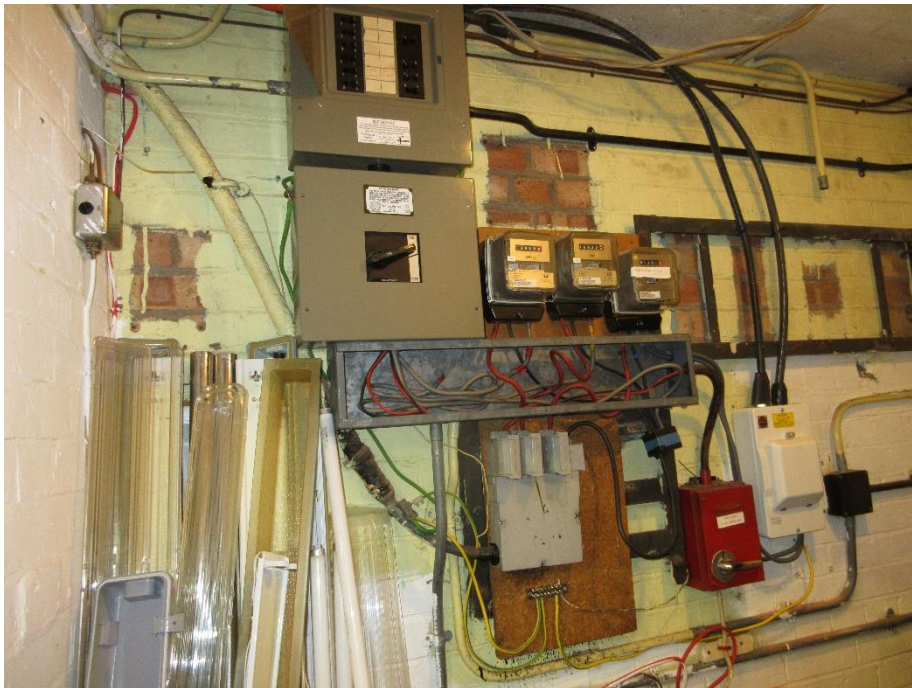
64. Incoming electrical supply, utility meter and distribution board

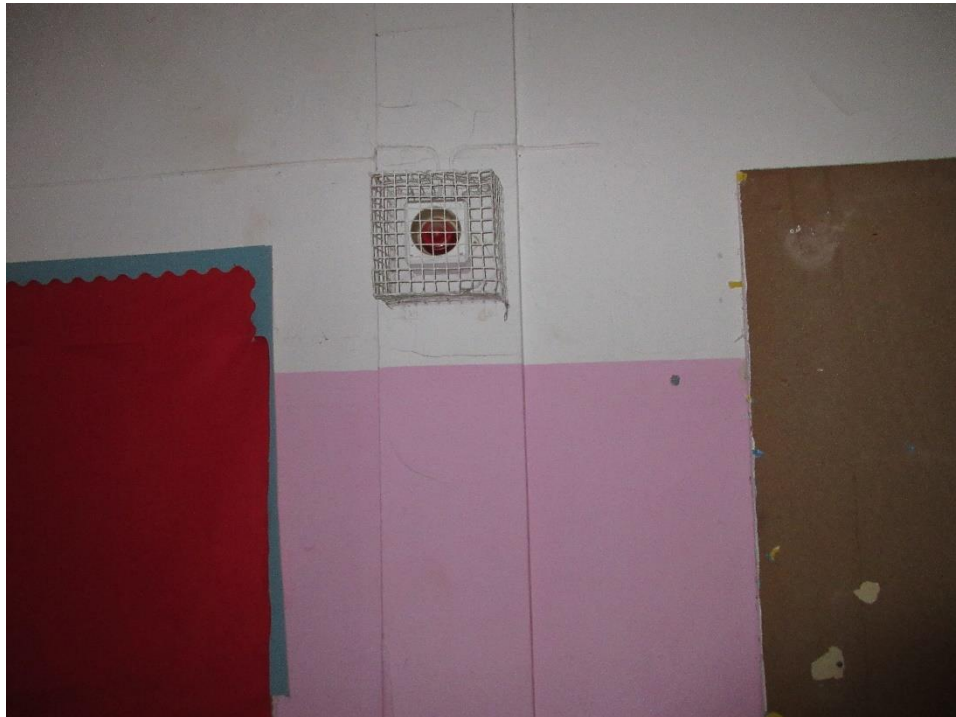
70. Fire alarm sounder/beacon
